STATE OF THE TAKIWĀ

Cultural Monitoring and Reporting
on the Health of our Environment

Te Āhuatanga o Te Waiau

Cultural Health Baseline Report 2005

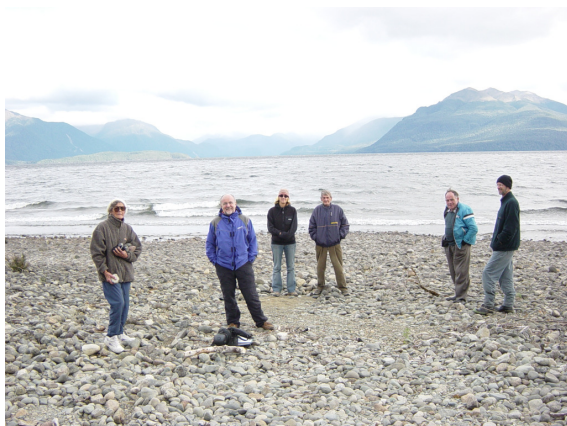
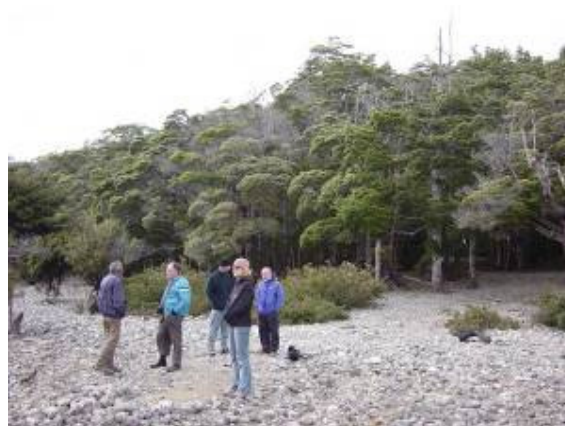
Fourteen Mile Site in 2005 – lakeside (left) and landside view (right)

Site Summary: The 14 Mile site ranked in the mid to top range of all the sites assessed. The positive aspects of the site were its ease of access and the almost total dominance of native vegetation. However, a negative aspect was the frequency and number of campers that stay at the site and the risk they pose in terms of contamination of the lake. While there were few weeds present, the campers could also pose a threat here. The E.coli and coliform results for the site were not high, but alarming none the less, as the presence of just 1 E.coli means the lake water would be unsafe to drink by New Zealand standards and demonstrates the harm camping can have on the lake.

Issues and Actions: Properly managing the campers and the risks they pose is amongst the most important follow up actions for this site. Controlling the few weeds may also be important to stop them spreading any further. Retesting, E.coli at the site would also be important to ensure the quality does not deteriorate or test how widespread the contamination may be.

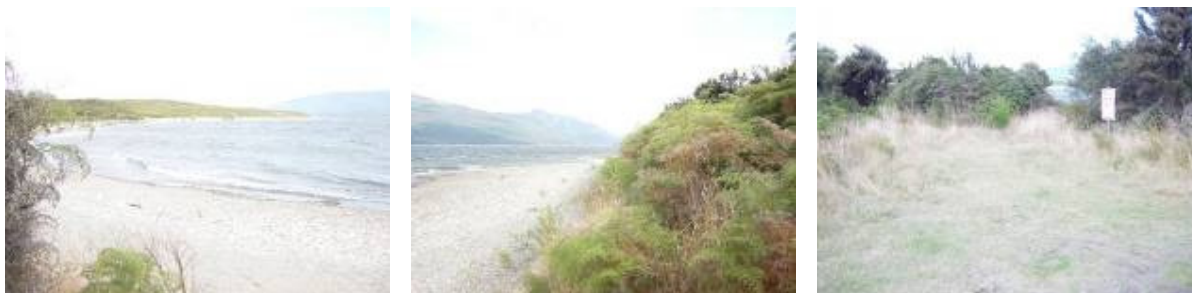
Nine Mile site in 2005 – lakeside view, showing bay (left) and view across to Te Ana-au (centre), and the inland view, showing nohoanga area (right).

Site Summary: The Nine Mile site again ranked in the mid range of all the sites assessed. Like the 14 Mile site, a positive aspect of this site was its ease of access, but this time because of it being a Ngāi Tahu nohoanga, it presented better opportunities to explore and enjoy the Lake, including the nearby Te Ana-au. The negative aspects of the site were the many weed species that were present and the open, exposed nature of the site. The E.coli and coliform results were again alarming, with higher counts here than at the 14 Mile Site, but overall not high enough to cause great concern, and is probably again related to camping.

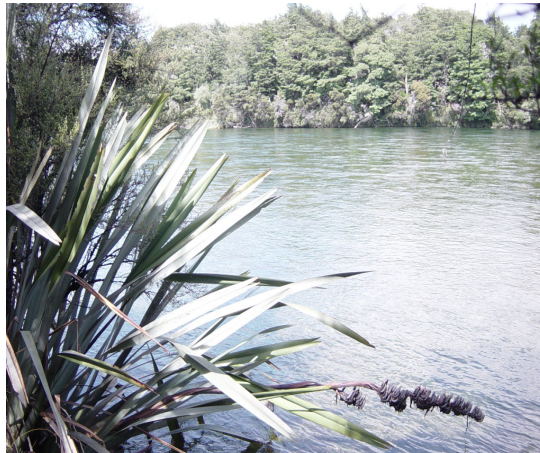
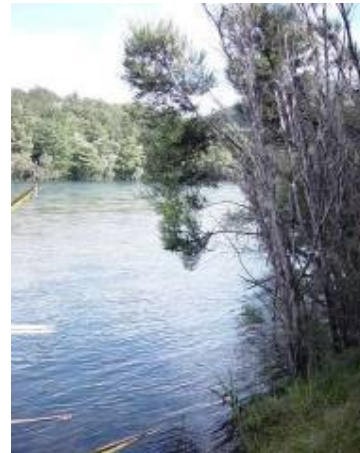
Queens Reach Site in 2005 – downstream (left) and upstream (right)

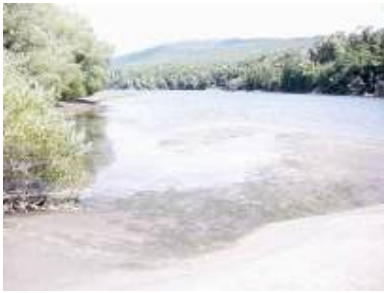
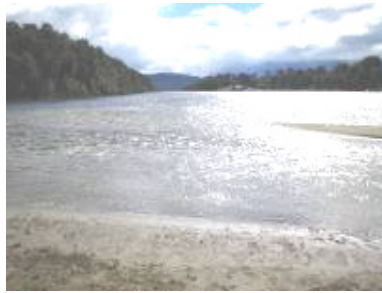
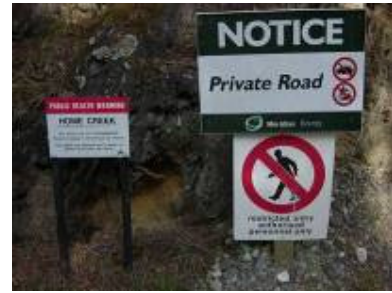
Home Creek in 2005 - downstream (left), showing 'muddy delta' and upstream (centre), showing mouth of creek and the view towards Lake Manapouri and the jetty where the water sample was collected. Private access and public health warning signs at the site (right).

Site Summary: The Home Creek site scored very poorly and was actually the worst of all sites assessed!! The biggest contributor to this grading was the obvious degradation caused to the area by the discharge of human effluent into Home Creek, with the muddy delta at the mouth of the creek giving physical evidence of this. The total dominance of Willows on the northern bank also figured poorly in the overall assessment of the site, as did the access issues related to the private road. Unfortunately, no water sample was gathered for this site, but instead was gathered further upstream at the Boat Jetty, which returned a result of 1 E.coli.

Issues and Actions: Investigating alternative treatment and disposal options for the discharge of human effluent into Home Creek could go some way to cleaning up this site. However, it would take a long time to repair the immediate damage caused at the mouth of the creek, if it could actually be restored at all in the eyes of those in the monitoring team.

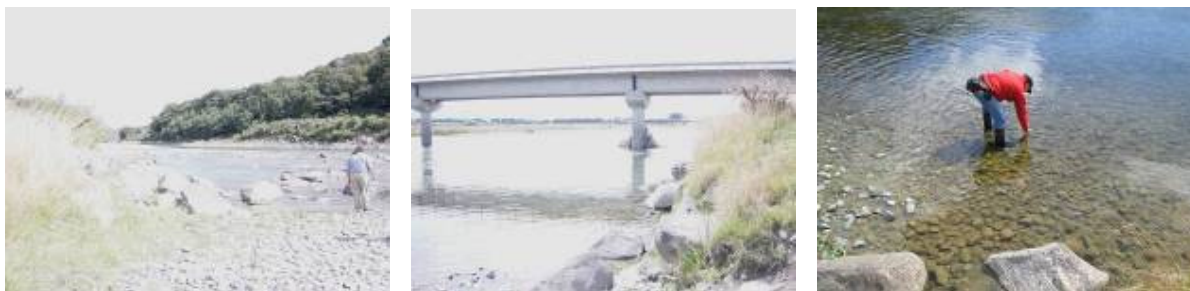
Mararoa Site in 2005: Downstream showing beech forest on opposite bank (left), upstream showing Mararoa weir passed the bridge (centre), and the extent of Didymo algae (right).

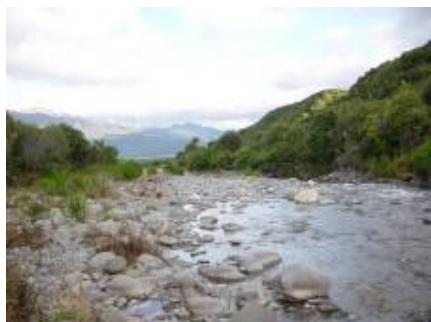
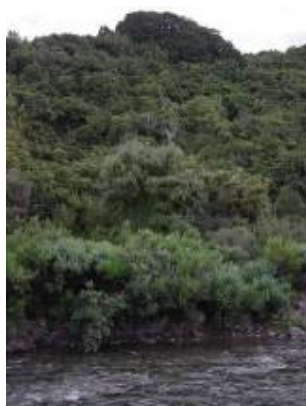
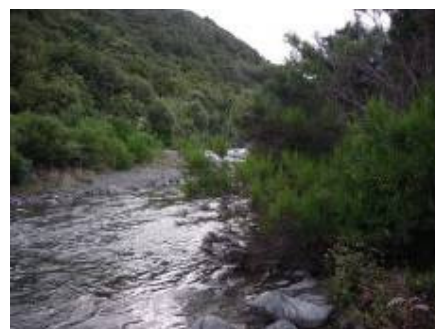
Redcliff Site in 2005: Downstream (left), at site, showing the 'escarpment' (centre) and upstream (right).

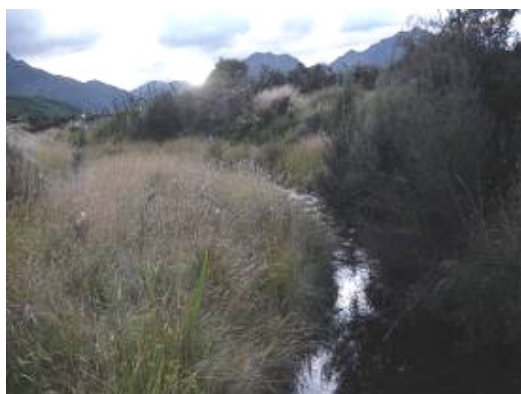
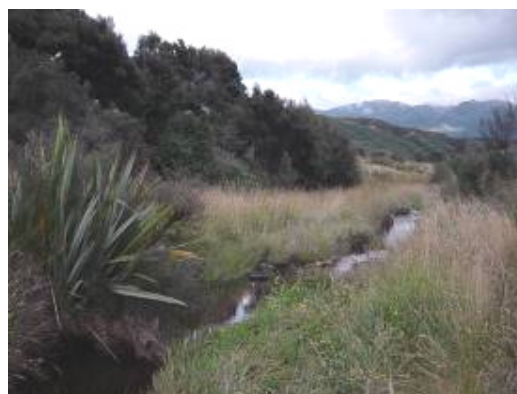
Jericho Stream in 2005: upstream (left) and downstream (right).

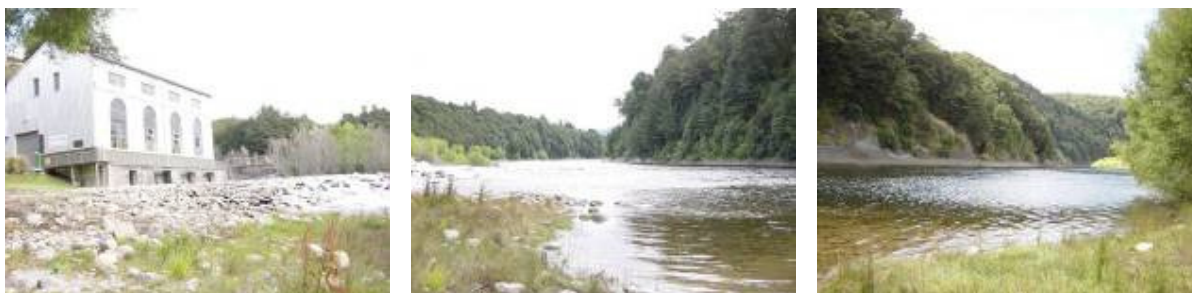
Monowai Power Station in 2005: Powerstation and Monowai River outlet (left),
Waiau River upstream (centre) and downstream (right)

Site Summary: The Monowai site ranked in the mid range of the sites monitored and was viewed favourably by the monitoring team. All said they would return to the site and most were willing to harvest mahinga kai from the area. One member noted 'Both rivers at this site have very little housing, therefore there is little pollution'. The reason for the site getting only an average score was due largely to the modification caused by the power station and power generation. The power station is a striking feature of the site and therefore detracts from the natural character of the place. In saying this, the extensive native beech forest on the opposite bank and up and down the river meant the site held potential for future harvest. The E.coli testing also showed only medium levels of contamination.

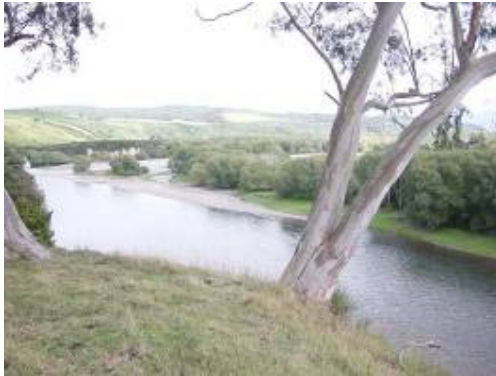
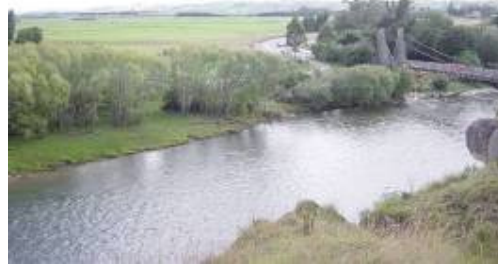
The Waiau at Clifden in 2005: Upstream towards the Lill Burn (left) and downstream, showing old Clifden bridge

Site Summary: The Clifden site scored in the mid to bottom range of all the sites monitored, although the entire monitoring team noted that they would definitely return to the site and were mostly willing to harvest mahinga kai from the area. The scores therefore represented the level of modification noted at the site, with the surrounding domination of farmland and the drops in river flow through hydro generation. The dominance of exotic plant species was also apparent in the low assessments of this site. The positive feature of this site was definitely the caves, which although being hugely modified, held a spiritual importance for the local tangata whenua. One member noted 'the caves are a part of our heritage and a place where we can always come to feel safe'. The Clifden site recorded high levels of E.coli, demonstrating potential contamination from the surrounding farmland. Overall this site was of medium to low cultural health, but of extreme cultural value – due mainly to the Caves, which represents an important taonga of the tangata whenua.

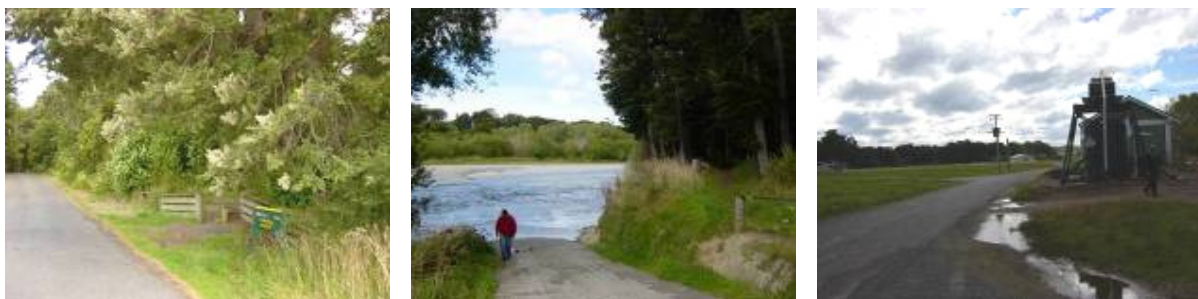
Tuatapere Domain in 2005: The resident beech forest on DoC reserve (left), the boat ramp looking downstream (centre) and the view of the domain area and water supply tanks (right).

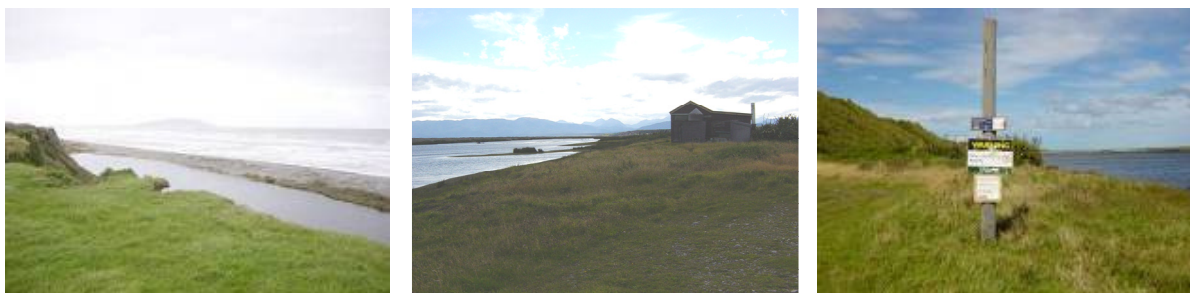
Te Waewae Lagoon-Matatarawae

Te Waewae Lagoon in 2005: Looking east from terrace (left), views to the west from the site (centre) and signs at the lagoon site looking east (right).

Site Summary: The Matatarawae site scored well in the CHI and other indexes, being in the mid to high range of all the sites monitored. This seemed due largely to the persistence of a range of mahinga kai species and the opportunities that remain for harvesting. Other factors were the relatively unmodified nature of the site, its sheltered conditions, good access and the impressive cliffs, almost totally dominated in native vegetation, that shadow the site. The area also appears well frequented by campers with baches, a toilet and signage all present. Overall this site has good cultural value and health and a good place to camp and gather kai.

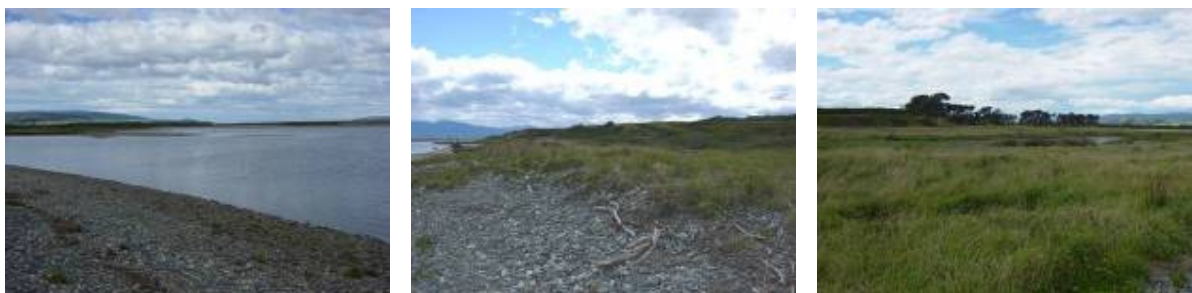
Papatotara-Te Tua a Hatu

Papatotara in 2005: upstream (left), downstream (centre) and wetland looking to the north (centre).

Issues and Actions: A small wetland is present near the site - it would be important to keep an eye on this for changes overtime. Fluctuations in river flow due to hydro power generation can cause noticeable changes at this site, which is worth keeping an eye on. Would be nice to properly identify the Nohoanga site nearby and instigate some restoration of Totara here. Further E.coli testing would be important to understand the nature and extent of contamination.

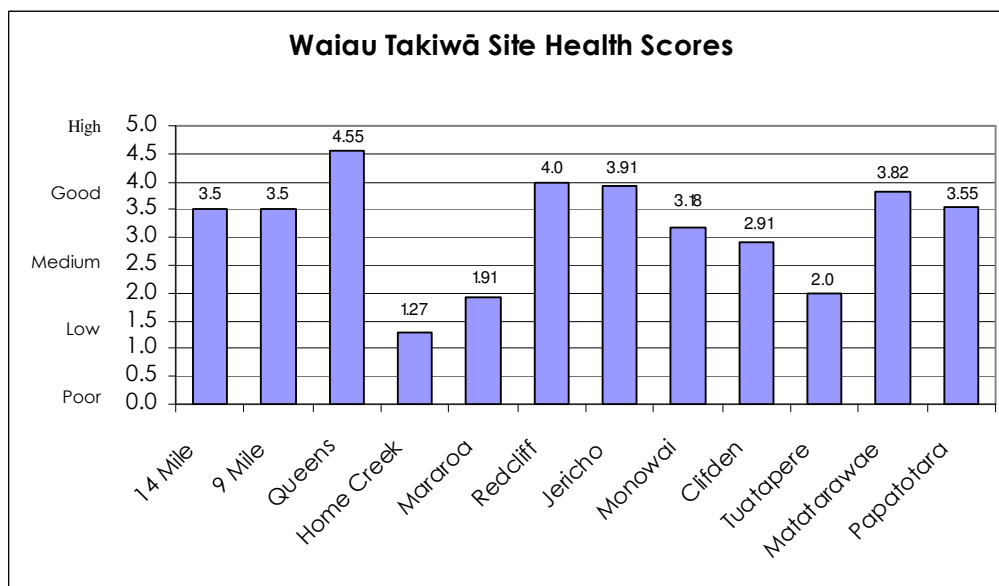
Of the 12 sites assessed, 8 were found to be of good to high health, while only 3 sites were found to be of a low to poor standard. The majority of sites (7) were found to be of good quality and 1 site - Queens Reach – was of high health, scoring 4.55/5. The lowest scoring site – Home Creek – received a poor ranking score of 1.27/5.

Generally, the higher scoring sites were those in the upper catchment – Queens Reach (4.55) and Lake Te Anau – 14 Mile (3.5) and 9 Mile (3.5), in tributaries – Redcliff (4.0) and Jericho (3.91), and at the mouth – Papatotara (3.55) and Matatarawae (3.82). These sites were characterised by either largely unmodified river flows and margins, native vegetation dominance, good access and/or potential for mahinga kai.

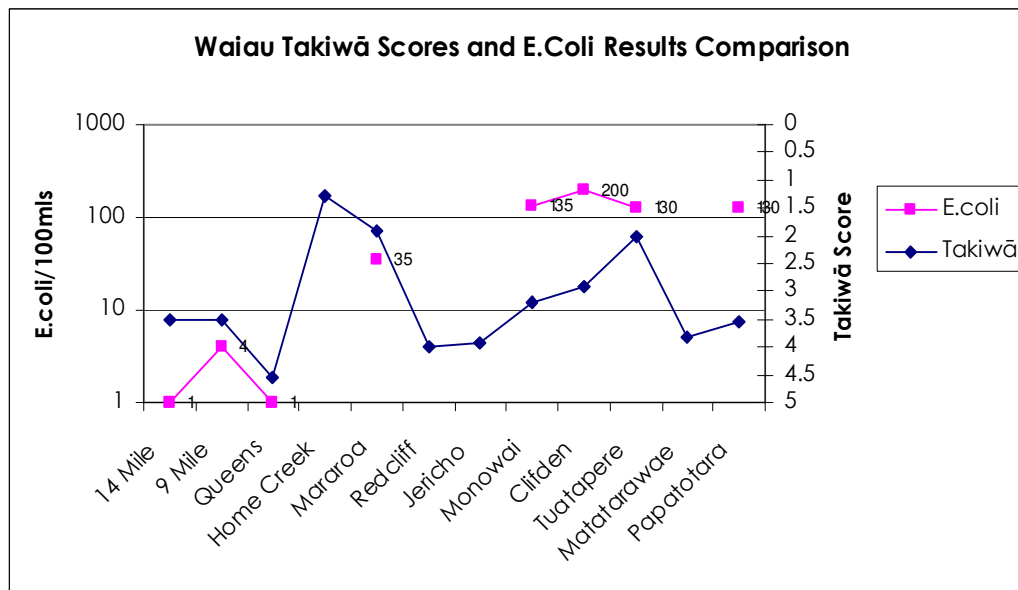
E.coli Results and Comparison

Exceptions to these trends were the Monowai (135) and Papatotara (130) sites, which although scored well in the Takiwā assessments, had high E.coli results. In fact these two sites returned worse E.coli results than the lower scoring Mararoa site.

Unfortunately, no sample was taken from the lowest scoring site – Home Creek – but instead a sample was taken upstream which returned an all most clean result. It was also unfortunate that no E.coli samples were taken for Matatarawae, Redcliff Creek and the Jericho Stream as the results would have been useful in providing a better overall picture and comparison.
