# STATE OF THE TAKIWĀ

## Cultural Health Assessment of the Mataura and Waikawa Catchments

Compiled by Craig Pauling

Maruaroa / June 2008

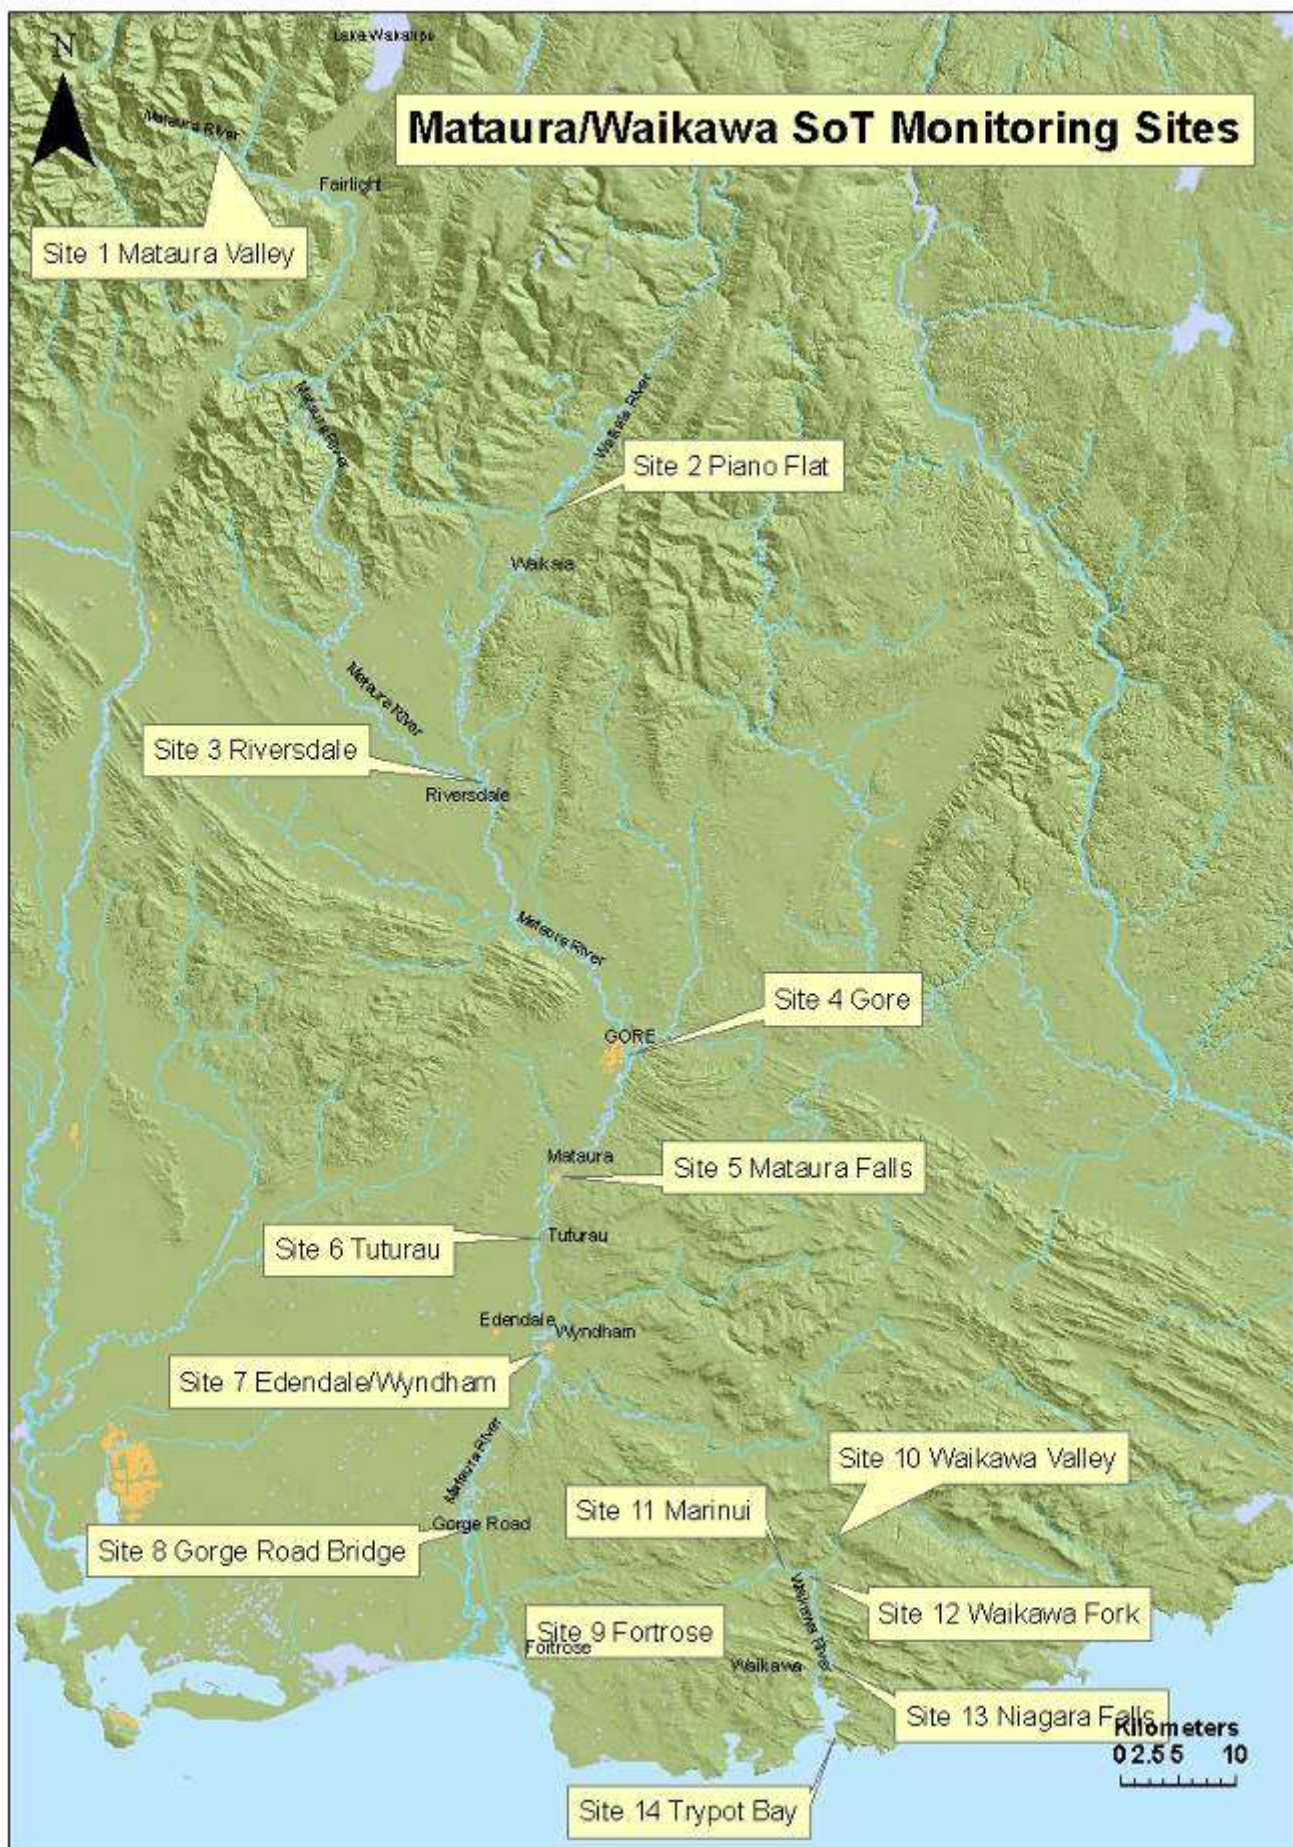
The location of these sites are shown on map 1 on the following page.

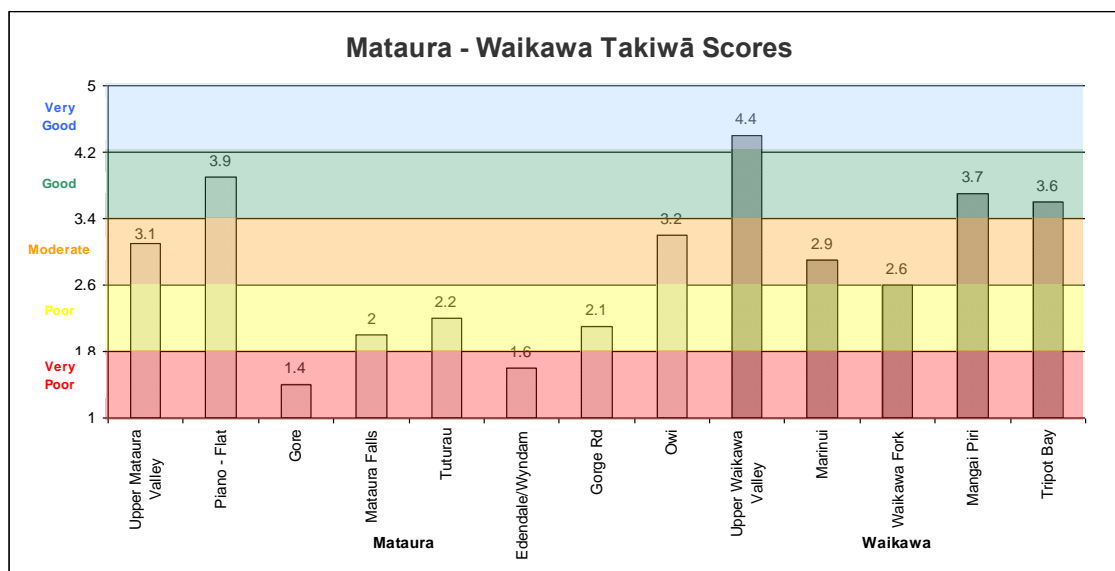
Takiwā assessment results for the Mataura catchment were poor. Of the 8 sites assessed, 37% were found to be of poor health, with a further 25% being rated as very poor. 25% of sites were also rated as moderate with the remaining 13% being rated as good. No sites were rated as very good. The total average score for sites across the catchment was 2.4 out of 5.

Takiwā assessment results for the Waikawa catchment were good. Of the 5 sites assessed, 40% were found to be in good health, with a further 20% being rated as very good, while the remaining 40% were rated as moderate. No sites

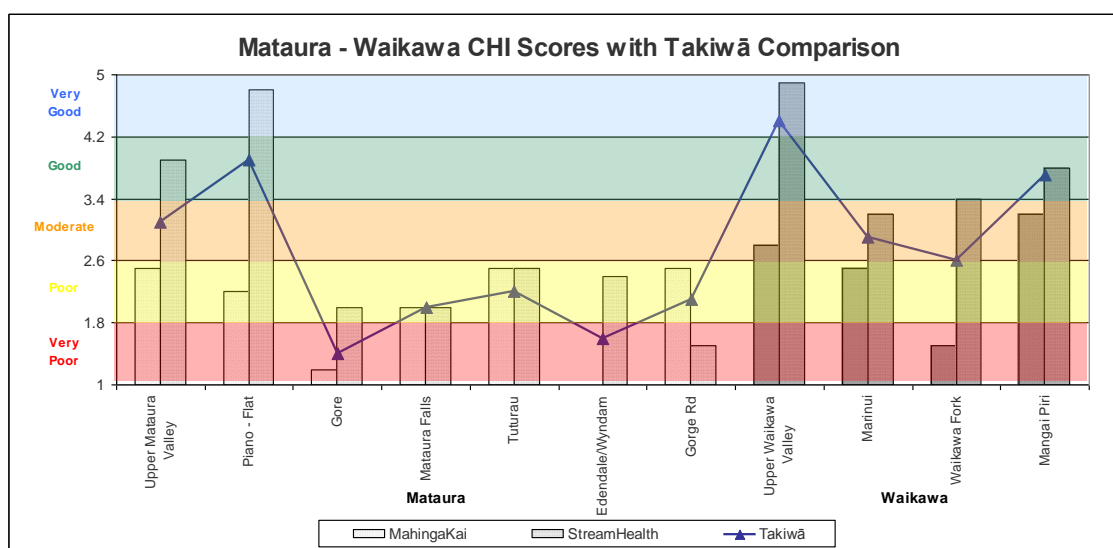
In the Waikawa catchment 50% of the sites were rated as good. Catchment and river margin landuse indicators were the most poorly rated, while river modification, water quality, water clarity and habitat variety indicators received high ratings.

The overall CHI results are shown in the graph below, along with a comparison to the Takiwā site scores.

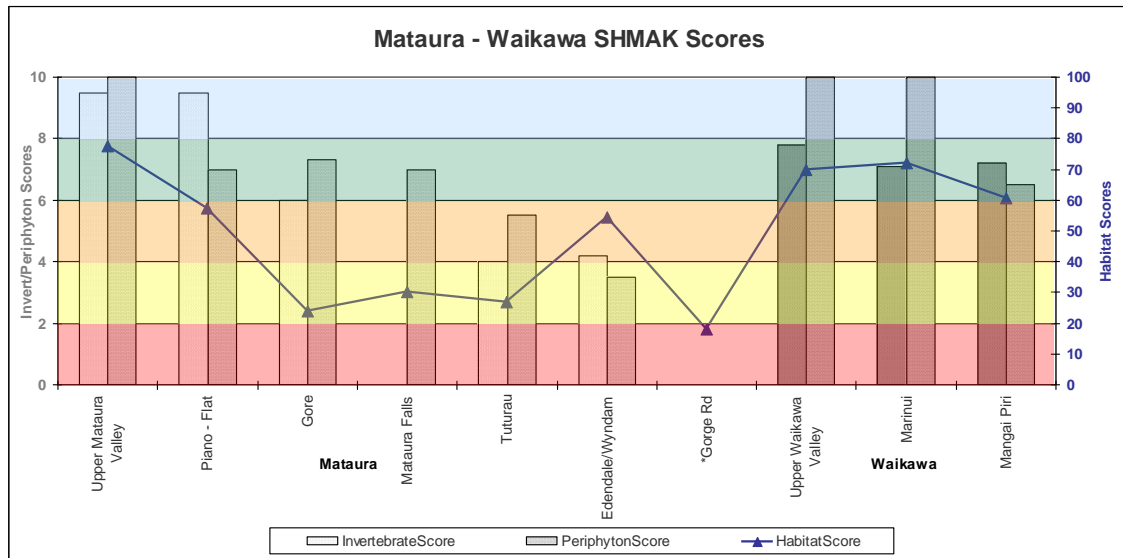
Only 10 sites were able to be tested using SHMAK, with the results being higher overall, but reflecting a consistent pattern with the Takiwā and CHI ratings across both catchments. Again the Waikawa catchment was considered healthier than the Matura catchment, and upper catchment sites being healthier than mid and lower catchment sites (excluding estuary sites).

The results are shown in the graph below.

\* Indicates an incomplete site record

In terms of the individual habitat indicators, bed, bank vegetation and deposit/sedimentation indicators scored poorly, while pH, temperature, conductivity and clarity indicators scored well in both catchments.

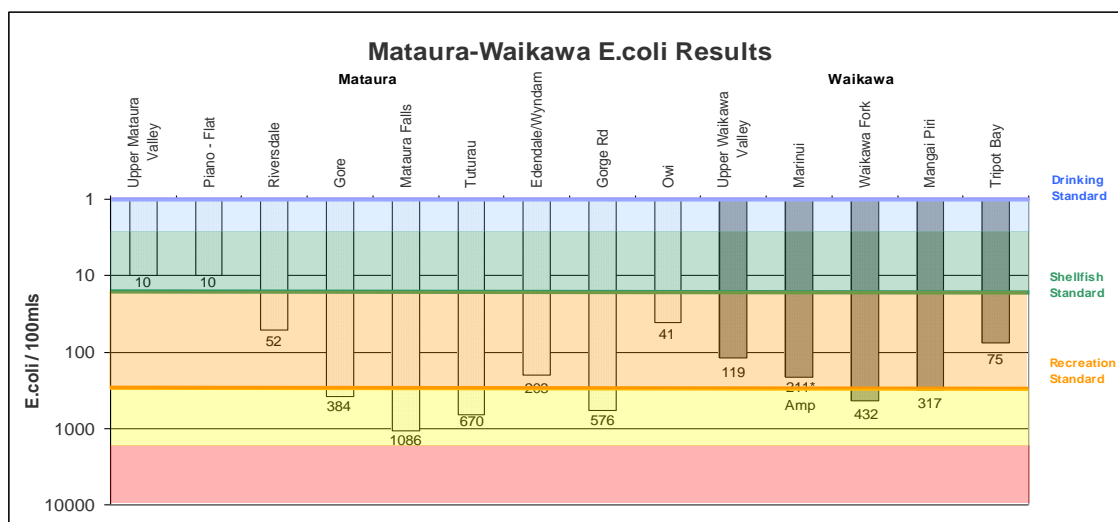
To add to the poor results overall, no sites were fit for drinking and almost half failed even the recreational standard for water quality.

These results are shown in the graph below.
