# State of the Takiwā 2012

Te Āhuatanga o Te Ihutai

## Cultural Health Assessment of the Avon-Heathcote Estuary and its Catchment

Date: Toru / July 2012

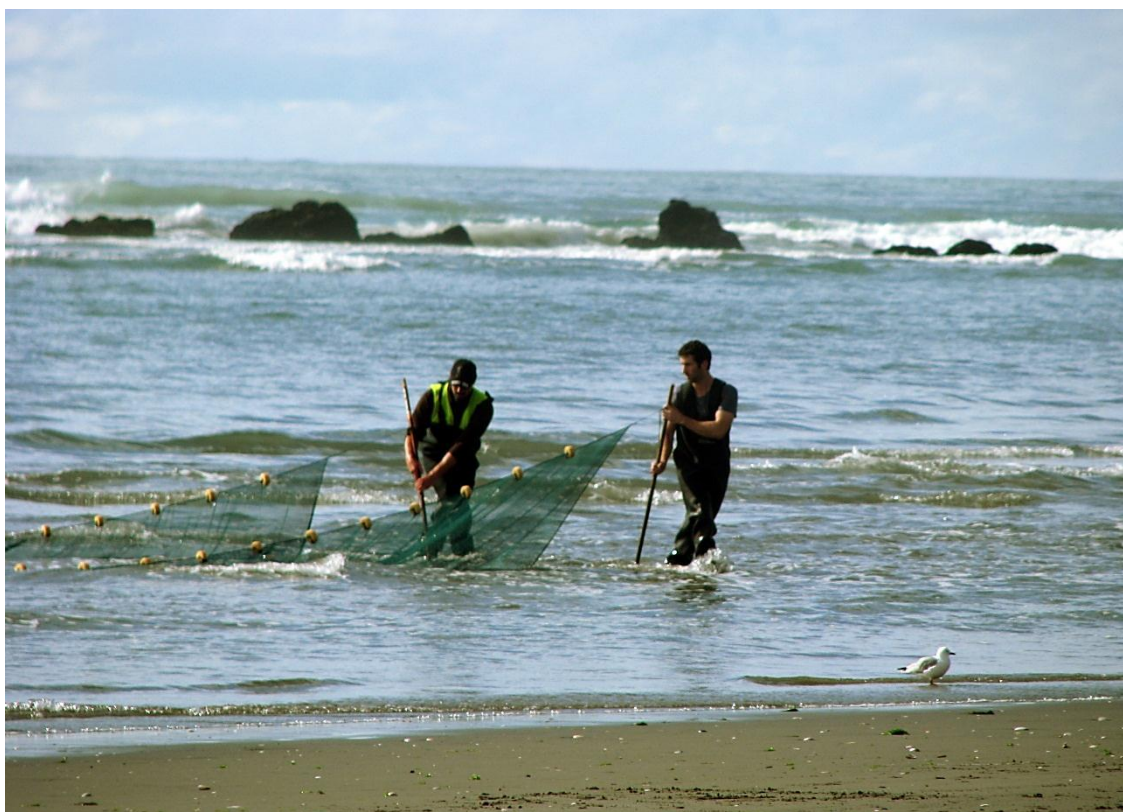
Figure 3: Location of fishing surveys

In addition hīnaki (fyke net) and drag-net fishing surveys were completed at other sites to provide further information on fish communities in the catchment (Table 2). Together they provided for the collection of information on fish communities from a further seven sites including those not suitable for electric fishing such as those which are not wadeable, or are saltwater localities (Figure 3).

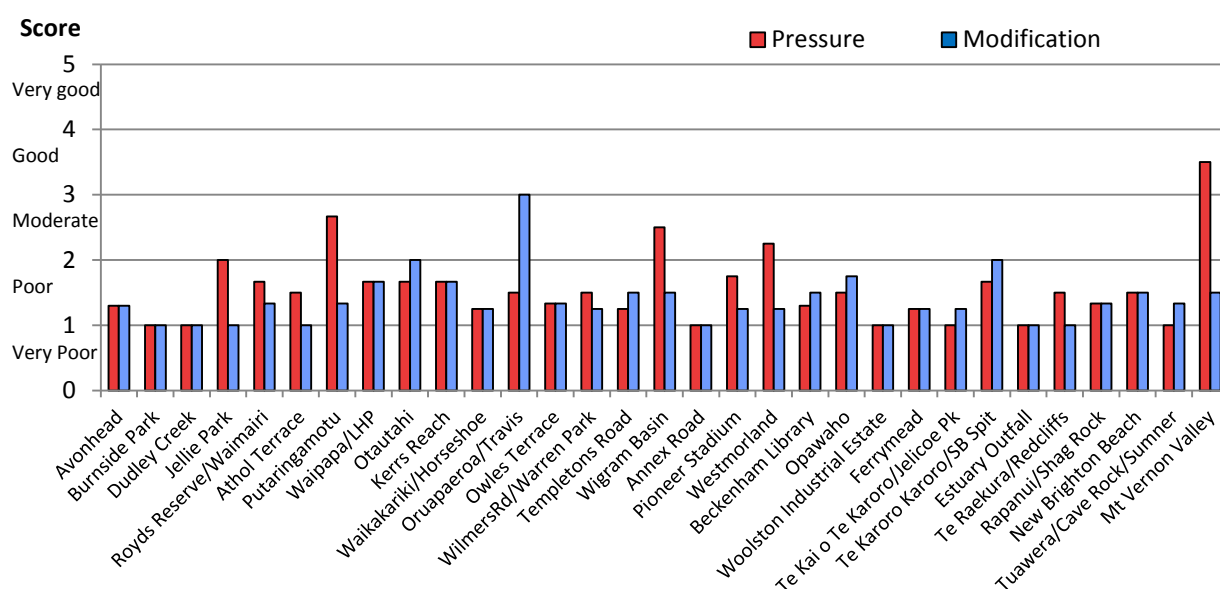
Figure 4: Scores for levels of modification and pressure on monitoring sites

A strong trend in the results was evident in the level of modification of sites (relative to traditional condition) and level of pressure on cultural values (Figure 4). Nearly all sites were considered to be highly modified and currently experiencing a high level of pressure indicating that current conditions in the catchment are not supportive of cultural values.

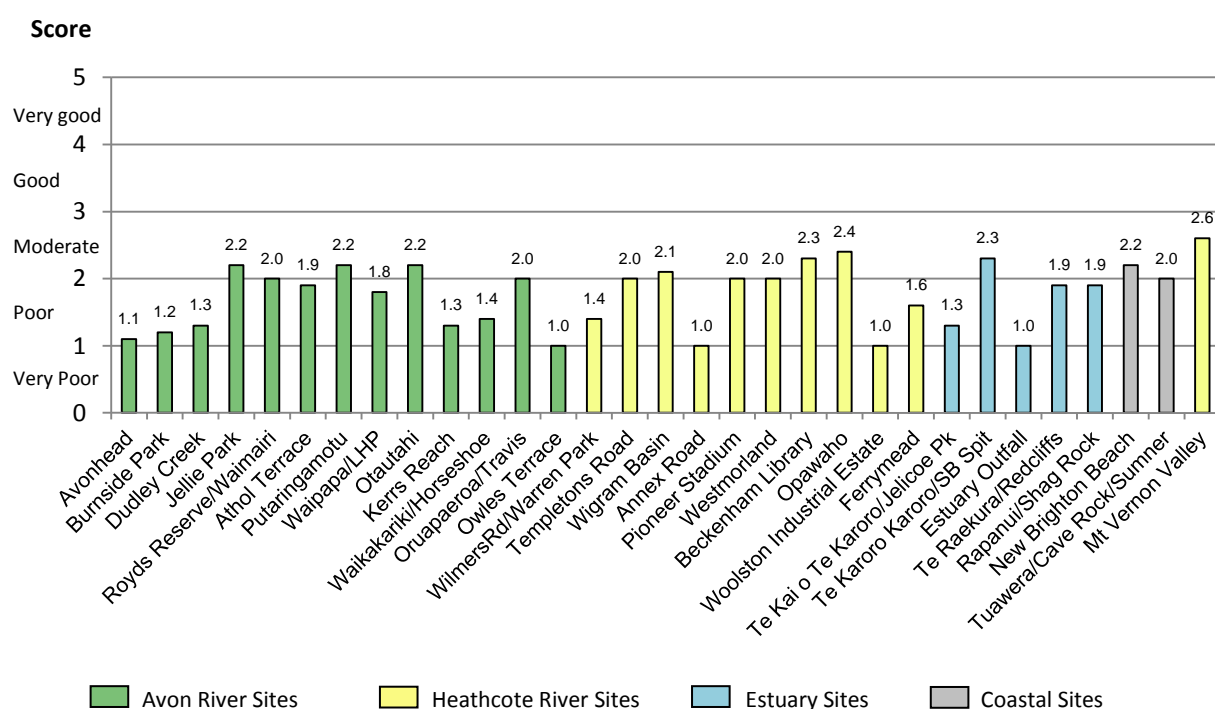
Figure 5: Takiwā 2.0 Overall Health Index scores

Results for the Takiwā 2.0 Overall Health Index scores for each site demonstrated that the condition of the Ihutai catchment is generally poor. 13% of sites were rated as very poor, with 39% rated as poor, and a further 48% scoring as moderate in terms of overall cultural health (Figure 5).

The site at Mt Vernon Valley / Rāpaki Track scored the highest (2.6/5), with Ōpāwaho scoring 2.4/5, Beckenham Library and Te Karoro Karoro / South Brighton Spit at 2.3/5, and Wairārapa / Jellie Park, Pūtārikamotu / Deans Bush, Ōtautahi and New Brighton Beach all scoring 2.2/5. In contrast, many sites across the catchment were rated very poorly with four sites equalling the lowest possible score of 1.0/5. These were Owles Terrace, Te Heru o Kahukura / Annex Rd, Woolston Industrial Estate and the Estuary Outfall.

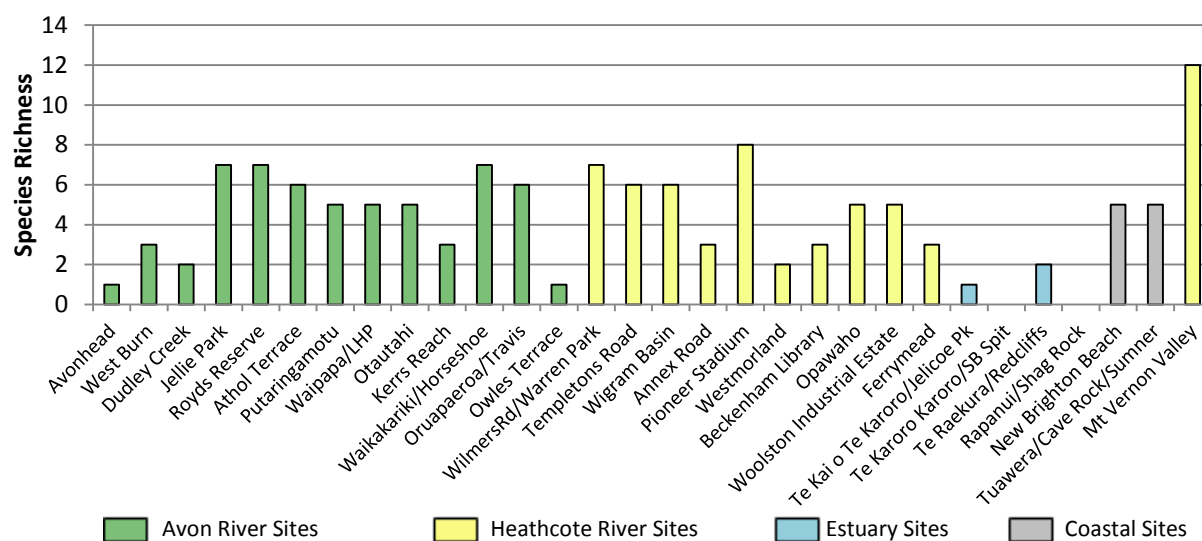
Figure 6: Vegetation richness\* of indigenous vegetation recorded at monitoring sites

Indigenous vegetation richness for species of interest varied across the catchment with the highest score recorded being at the Mt Vernon Valley / Rāpaki Track site (Figure 6). The most frequently recorded species were ti kouka (cabbage tree), identified at 21 of the 31 sites, and harakeke (flax) found at 17 sites.

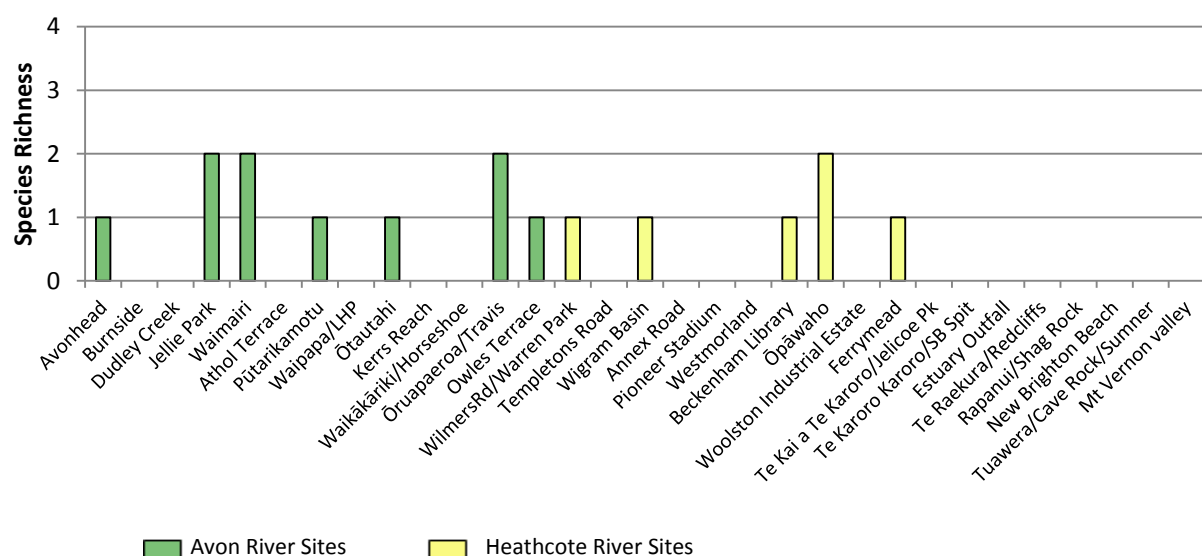
Figure 7: Species richness of indigenous birds recorded at monitoring sites

The overall abundance of indigenous bird species was low. At just 12 sites native birds were positively identified, with a maximum of two species being recorded at any one site (Figure 7). Putakitaki (paradise duck) was the most widespread of native birds identified at seven sites, with karoro (black billed gull) and pukeko identified at 2 sites. Other native bird species recorded were tui, piwakawaka (fantail), kereru (NZ pigeon) and korimako / kopara (bellbird).

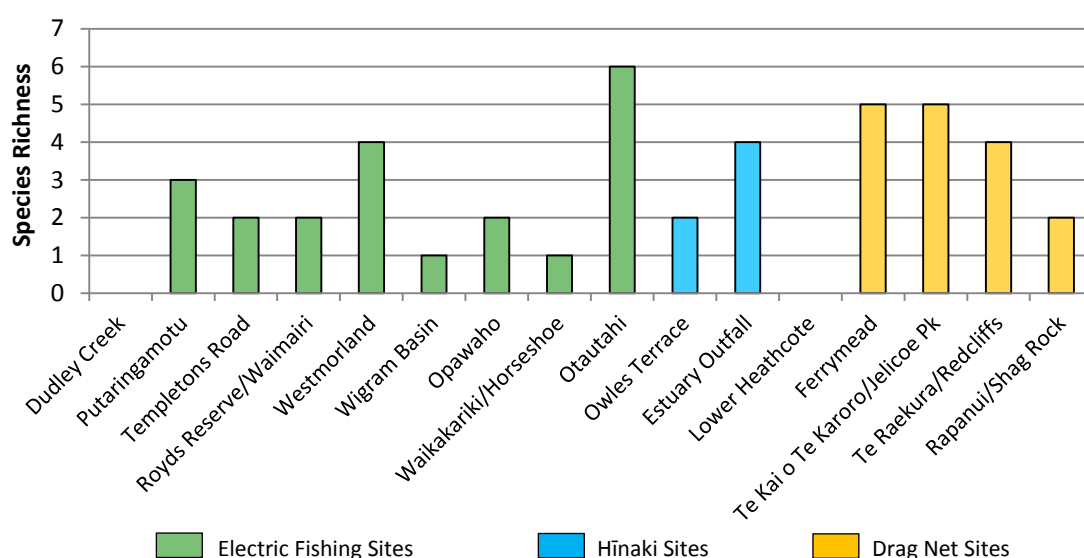
Figure 8: Species richness of indigenous fish species recorded at monitoring sites

The combined use of the three different fish survey techniques provided information on fish species from a selection of sites across the catchment. Ten fish species were recorded in these surveys, being tuna paku (shortfin eel), tuna roa (longfin eel), common bully, brown trout, giant bully, yellow-eyed mullet, herring, smelt, inaka (whitebait) and patiki (flounder). Although providing only a snapshot the hīnaki and drag netting results may be related to mahinga kai values since they are an example of the catches obtained through use of traditional fishing technique on a single occasion at each site.

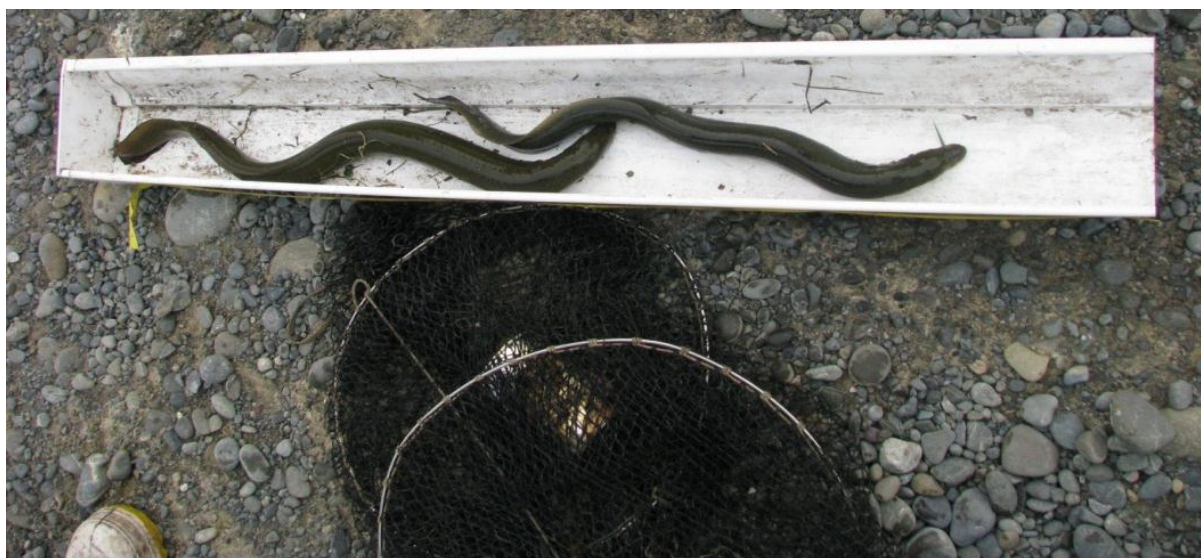
*Figure 9: Tuna paku (Shortfin eel) from hīnaki at Owles Terrace*

Hīnaki nets produced mixed results at the three locations where they were used. At Owles Terrace five short fin eel (ranging from 33 to 61cm in length) were identified. The Ocean Outfall site had the highest diversity, although low abundance, with a single giant gully, shrimp, a common bully and herring recorded. In contrast, a hīnaki set at the Woolston Cut did not yield any fish.

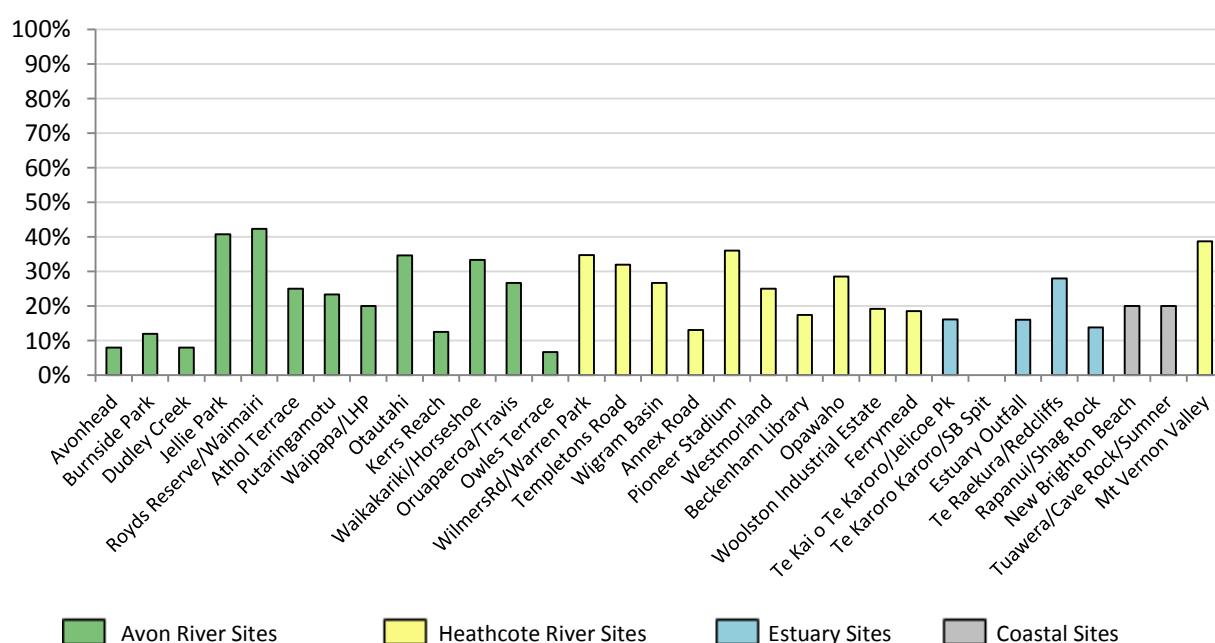
Figure 11: Number of species recorded during monitoring as a percentage of those traditionally present at each site for selected taxonomic groups

A comparison of the number of taxonomic groups of indigenous species recorded during the monitoring visit versus the number regarded as being traditionally present provides an indication of the ability of the site to sustain traditional Ngāi Tahu values. Although not all species traditionally present would be expected to be present and recorded during a single monitoring visit, surveys were completed for plant, bird and fish species. For these taxonomic groups the results show that at most sites across the catchment between ten and 40% of species traditionally present were recorded during monitoring. The sites at which higher percentages were recorded were typically those with remnant or restored indigenous vegetation in the riparian zone (Figure 11).

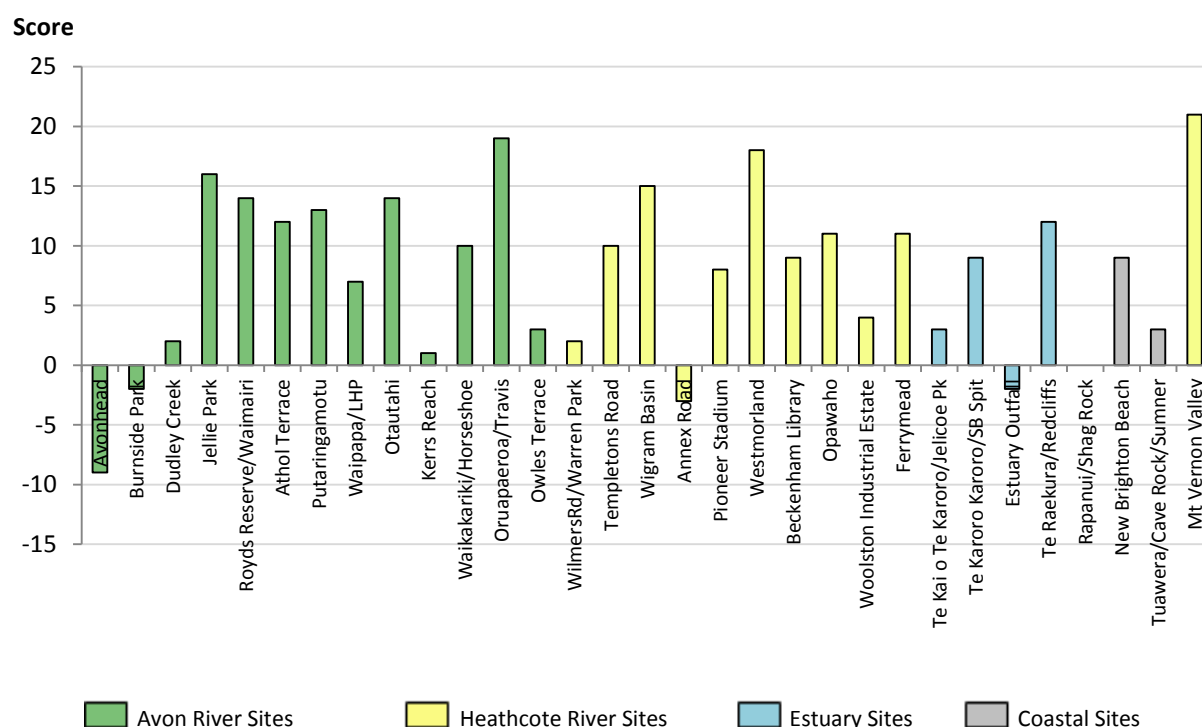
Figure 12: Abundance Index scores as calculated in Takiwā 2.0

Takiwā 2.0 calculates an Abundance index which considers the abundance of native species as a positive value and the abundance of exotic species as a negative value. Negative values therefore relate to higher proportion of exotics, and positive to higher proportion of indigenous species (Figure 12). Vegetation, bird and fish species are considered.

This index provides an indication dominance of native species in comparison to exotic species recorded. Although there is no maximum score to the index, higher scores indicate greater dominance of native species versus exotics. Most sites across the catchment returned low positive scores indicating the presence of indigenous species. It is worth noting that the presence of pasture grasses and exotic weeds were recorded as a single taxonomic group since the focus of the vegetation assessment methodology was on the shrub and tree species present. This aspect influences the Takiwā 2.0 Abundance Index result which could be interpreted as showing that indigenous species are dominant at many sites, whereas in reality pasture grasses and exotic weed species were often the dominant species present in terms of percentage cover for vegetation.

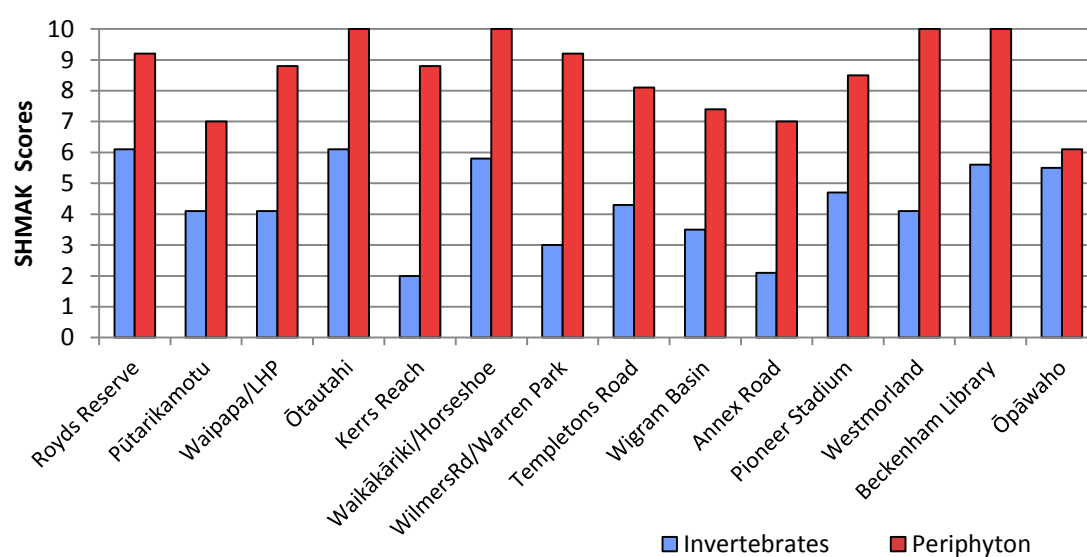
Figure 14: SHMAK Invertebrate and Periphyton scores

Invertebrate scores ranged between 2 and 6 indicating the in-stream habitat was generally below average in the catchment. The lowest scores were recorded at Kerrs Reach and Annex Road, and the highest at Royds Reserve, Ōtautahi and Horseshoe Lake. Scores from the periphyton assessment ranged between 6 and 10, indicating relatively healthy in-stream conditions for periphyton (Figure 14).

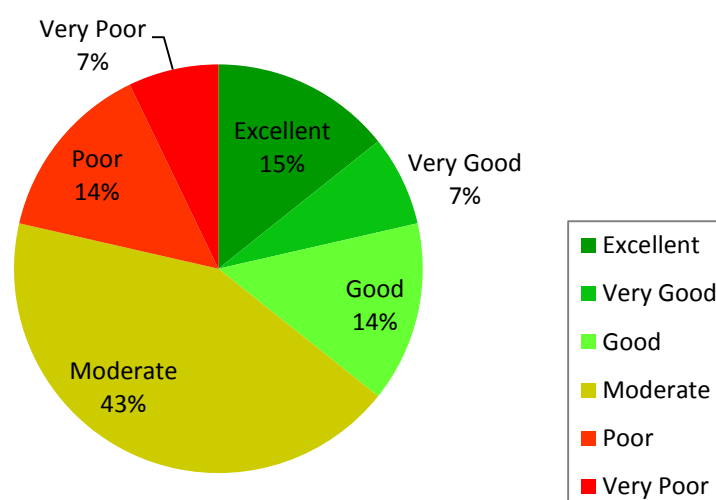
Figure 15: SHMAK assessment of overall stream health across the 17 sites assessed using the SHMAK method

The SHMAK method also provides for an assessment of overall stream health based on the combined scores of invertebrate and periphyton assessments. The majority of monitoring sites were assessed as being in moderate condition (Figure 15). This reflected the presence of at least some attributes which are associated with good stream health. However, it should be noted that the range of attributes informing this assessment are not culturally specific assessment. Generally the periphyton scores indicated better stream health than invertebrate scores and this is reflected in the range of overall stream health scores obtained.

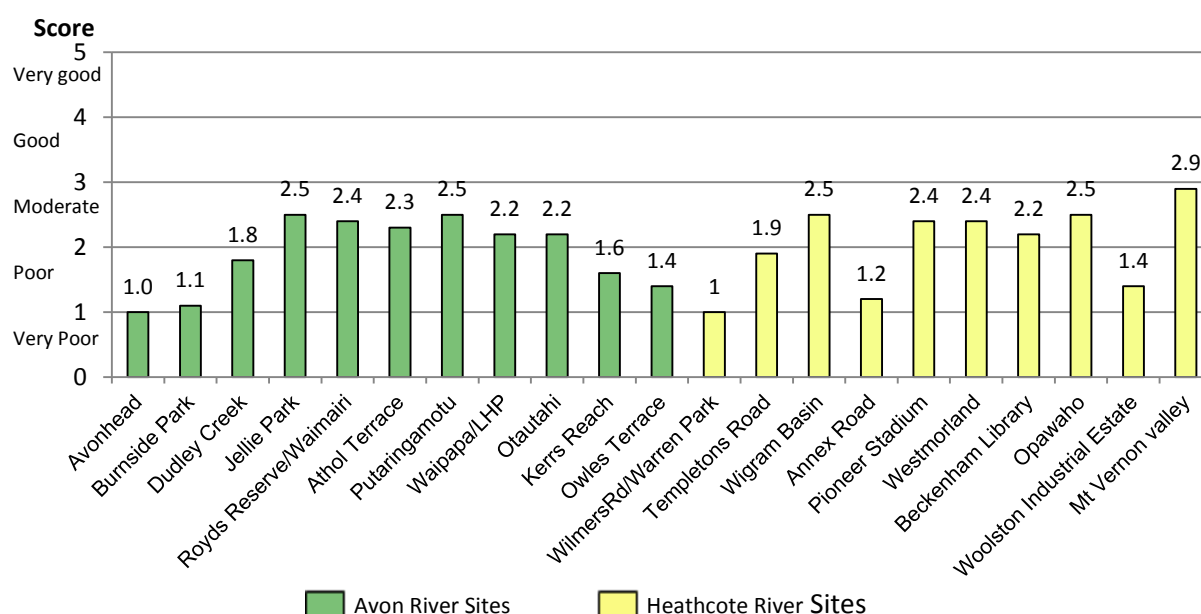
Figure 16: CHI Cultural Stream Health Assessment scores

Results from CHI Stream Health Assessments indicate stream health is below average, and are in-line with results indicated in the Takiwā General Site Assessments.

These results consistently indicated lower levels of stream health across the catchment than obtained using the SHMAK method, and no sites in the catchment were assessed as being in good or very good condition using the CHI method for stream health. This likely reflects the lower weighting applied to periphyton assessments. In other respects the CHI method takes more attributes of a site into account, and importantly the range of assessment topics used are culturally-specific.

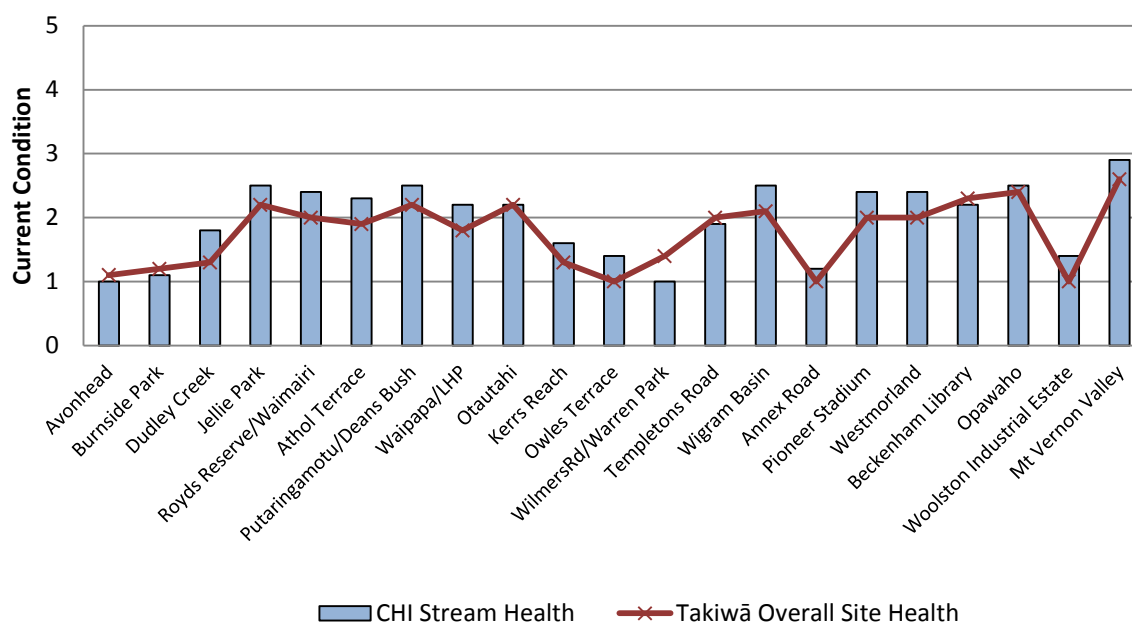
Figure 17: Comparison between CHI Stream Health scores and Takiwā 2.0 Overall Site Health scores

When the CHI Stream Health Assessment results were compared with Takiwā Overall Site Health scores there was much similarity in the results (Figure 17). Although the components of each assessment involve different parameters and assessment questions, the focus of both assessments is on culturally relevant indicators of environmental health.

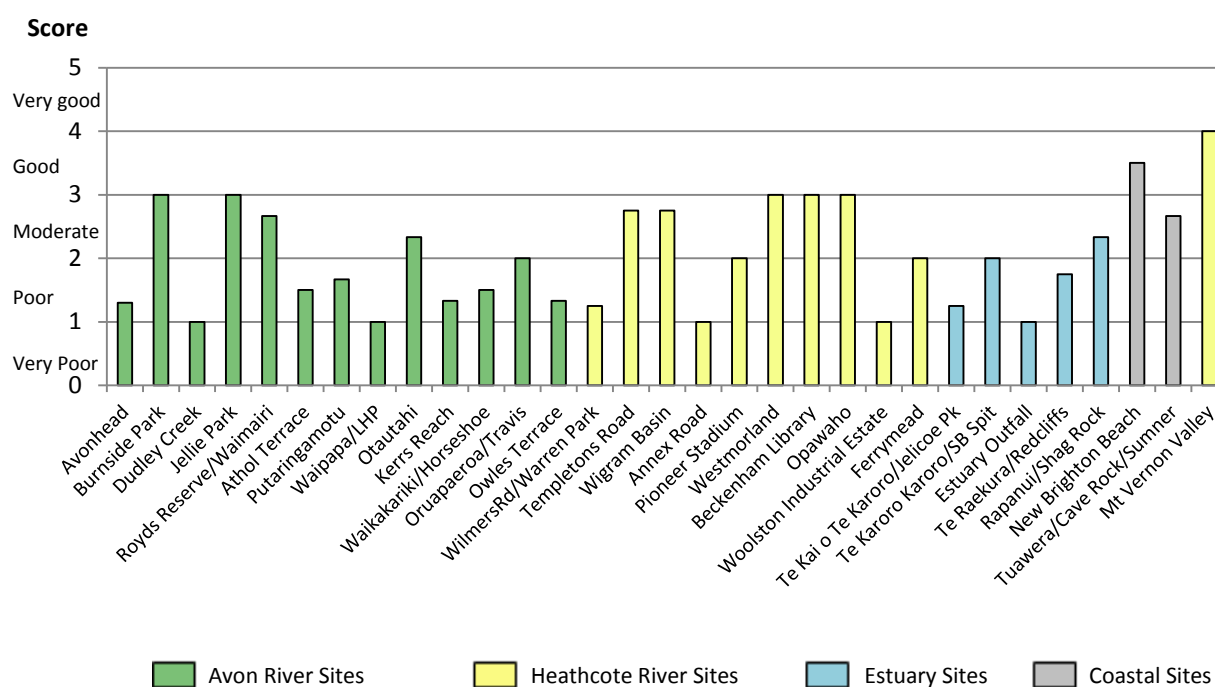
Figure 19: Suitability for harvesting mahinga kai

At most sites scores for the suitability of monitoring sites for harvesting mahinga kai were between one and three, indicating poor to moderate culture health. Only two sites were assessed as being “good” or better for harvesting mahinga kai, these being Mt Vernon Valley and New Brighton Beach. Five sites were scored 1/5 which is the lowest score possible, indicating that these sites were highly degraded in terms of suitability for harvesting mahinga kai (Figure 19).

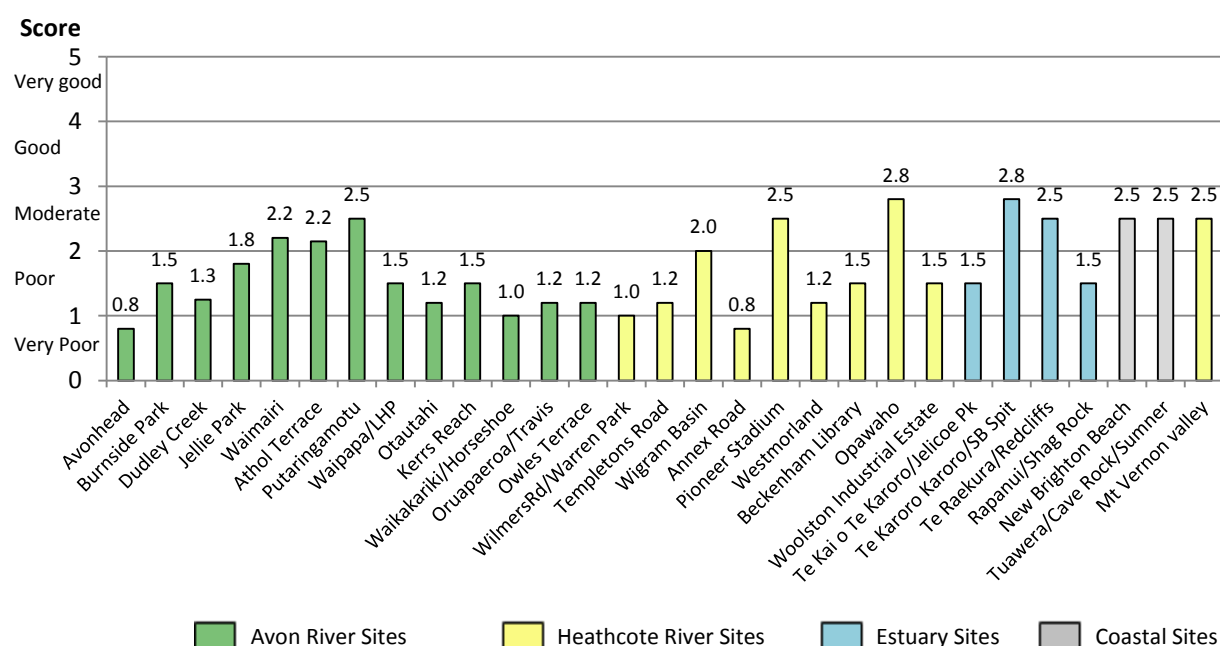
Figure 21: CHI Mahinga Kai Index scores

Assessments of mahinga kai values showed that most sites in the catchment were in below average condition. 14% of sites were rated as very poor, 52% as poor and 34% as moderate in terms of mahinga kai values with no sites with a good rating (Figure 21). Avon / Ōtākaro sites were slightly higher on average at 1.5, with Heathcote / Ōpāwaho sites averaging 1.6, and coastal sites at 2.4.

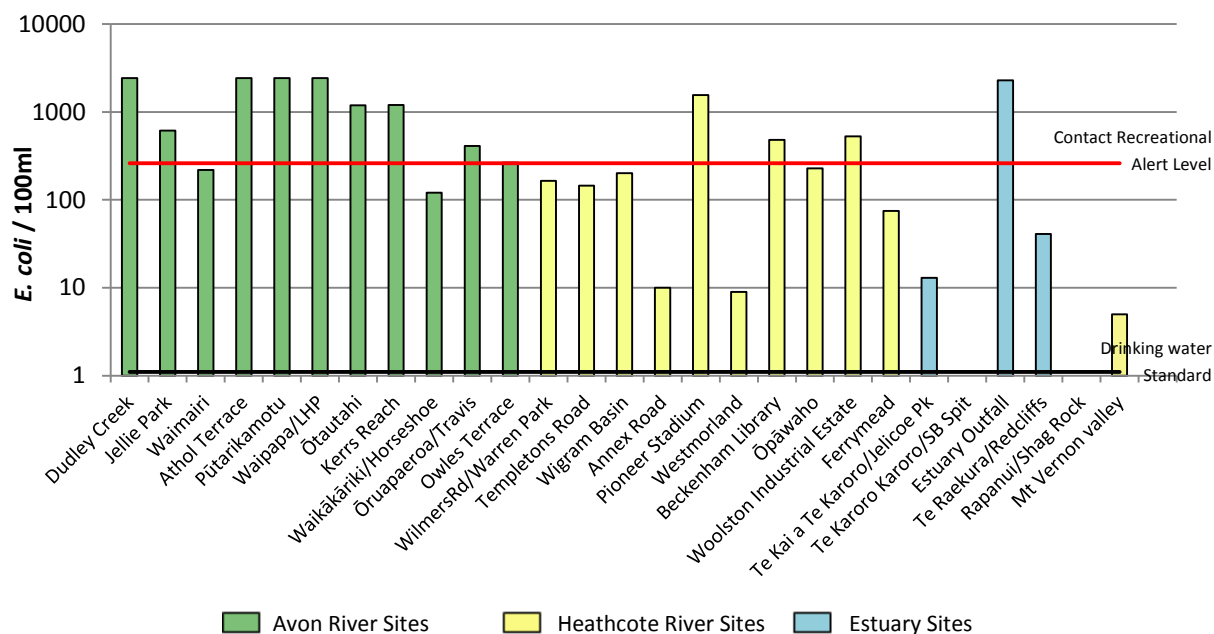
Figure 22: Results of *E. coli* testing

45% of sites exceeded the Recreational Alert level of 260 *E. coli* /100ml at the time of sampling (see Appendix 5). In the Avon / Ōtākaro catchment all but two sites exceeded the contact recreational standard. In the Heathcote / Ōpāwaho catchment 40% of sites exceeded this standard at the time of sampling. *E. coli* levels were significantly higher in the Avon River overall. However, it is important to consider that values are highly variable on a daily basis and are influenced by a number of factors.

A value of 2420 *E. coli* /100ml is the upper limit of measurement in the direct method and was recorded at four sites. Actual *E. coli* levels at these sites were therefore equal or greater than 2420 *E. coli* /100ml. However, these four sites were sampled directly following rainfall events, which is known to influence *E. coli* values (Moriarty & Gilpin, 2009), and especially so in the post-earthquake context.

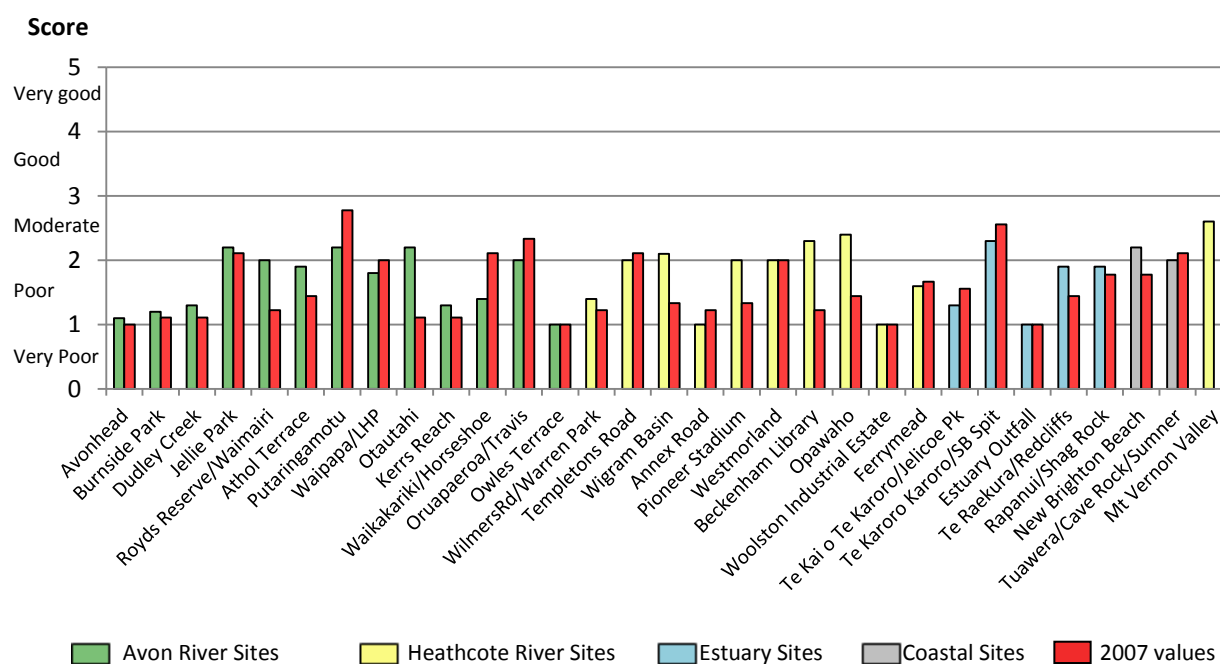
Figure 24: Comparison between Takiwā 2.0 Overall Site Health scores from 2007 and 2012 monitoring programmes

Results from this monitoring programme indicate that the current condition of the Ihutai catchment remains poor, and is comparable to the findings reported in the previous monitoring programme (Pauling et al., 2007). The following graph depicts a comparison between Takiwā Overall Site health scores from 2007, and from the 2012 monitoring programme (Figure 24).

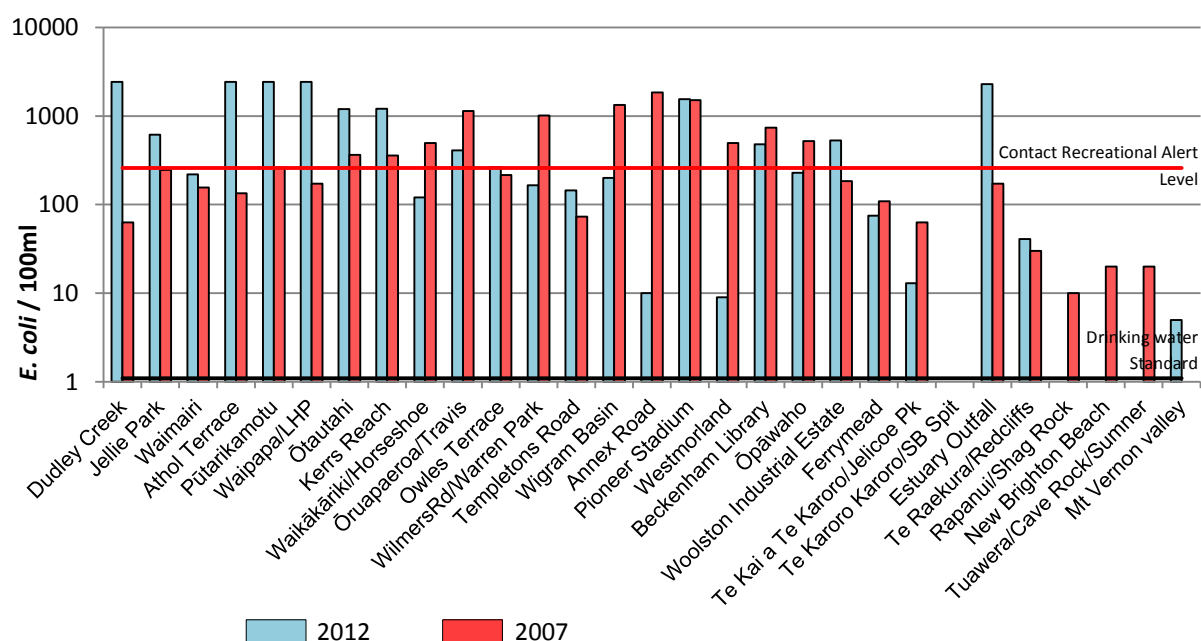
Figure 25: Comparison between *E. coli* sampling results from the 2007 and 2012 State of the Takiwā monitoring programmes

Results from the two State of the Takiwā programmes indicate that *E. coli* levels in the catchment are high relative to the Contact Recreation Alert Level, with many sites exceeding that level. Comparison of *E. coli* data between the two years shows the variable nature of one-off sampling, but nevertheless provides useful information. In the 2012 study, lower *E. coli* levels were recorded at Annex Road and Westmorland observed. Large increases were recorded at other sites including Estuary Outfall, Dudley Creek, Athol Terrace, Pūtarīkamotu and Waipapa (Figure 25).

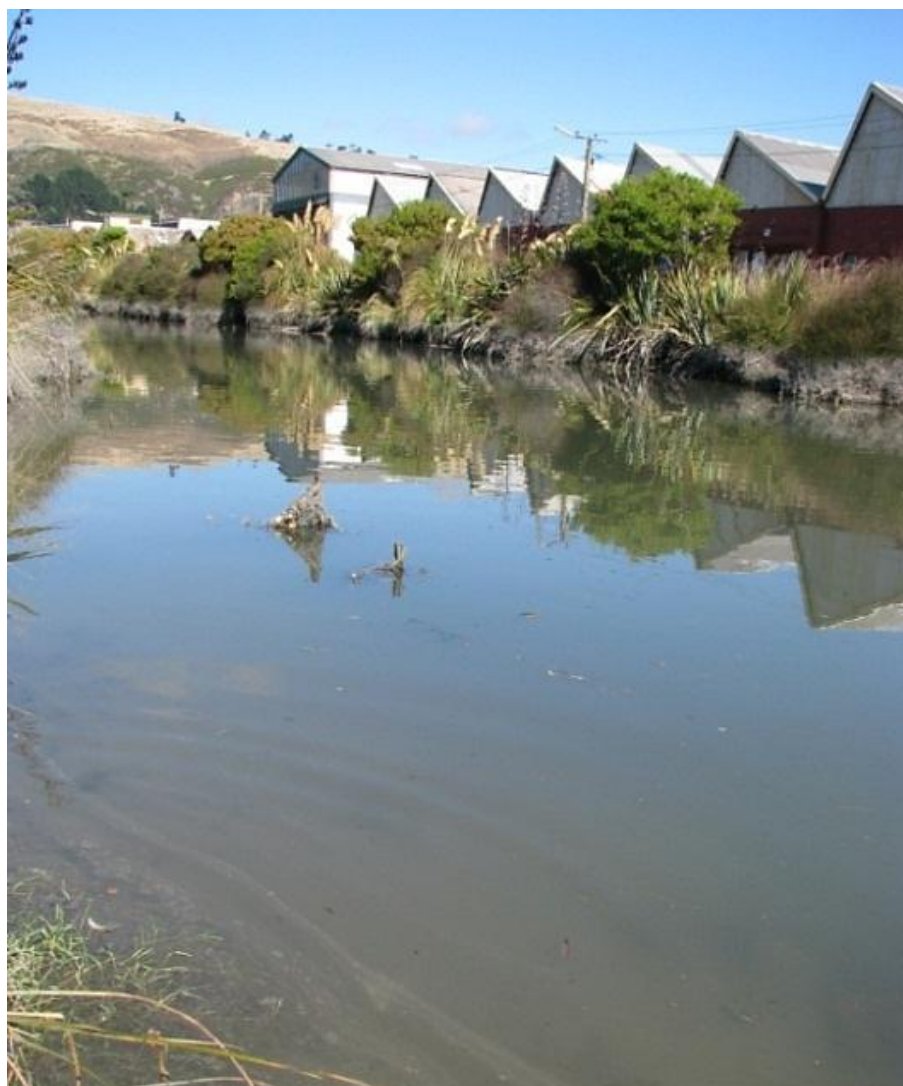
*Figure 26: Example of a site in poor cultural health at Woolston Industrial Estate*

- Specific enquiry into all heavily degraded sites (for example Woolston Industrial Estate) and identification and implementation of remedial actions to improve the health of those sites.

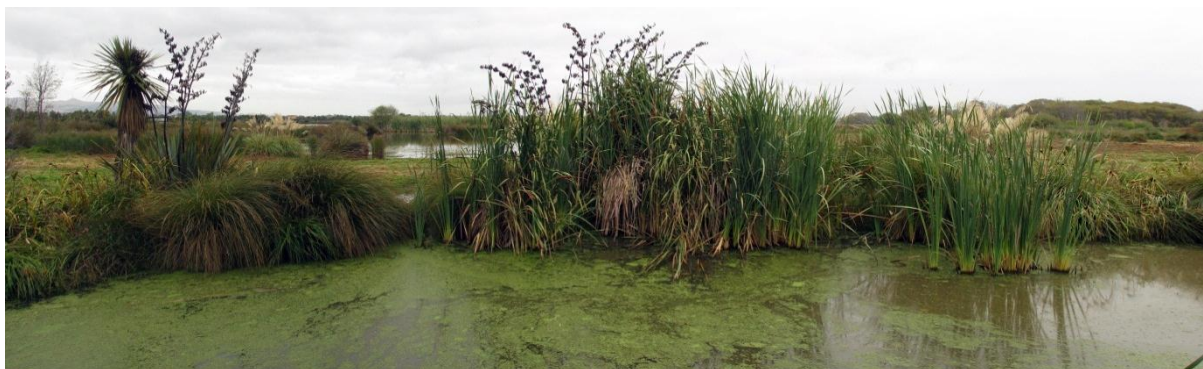
However, some sites have undergone extensive restoration and/or conservation initiatives. Examples including Pūtarikamotu (Deans Bush), Ōruapaeroa (Travis Wetland), Waikākāriki (Horseshoe Lake) and Wigram Basin sites scored well across a variety of cultural health indicators (Figure 27).

*Figure 27: Example of a restored site at Ōruapaeroa / Travis Wetland. Culturally important vegetation present includes Ti Kouka, Harakeke, Raupo and sedges*

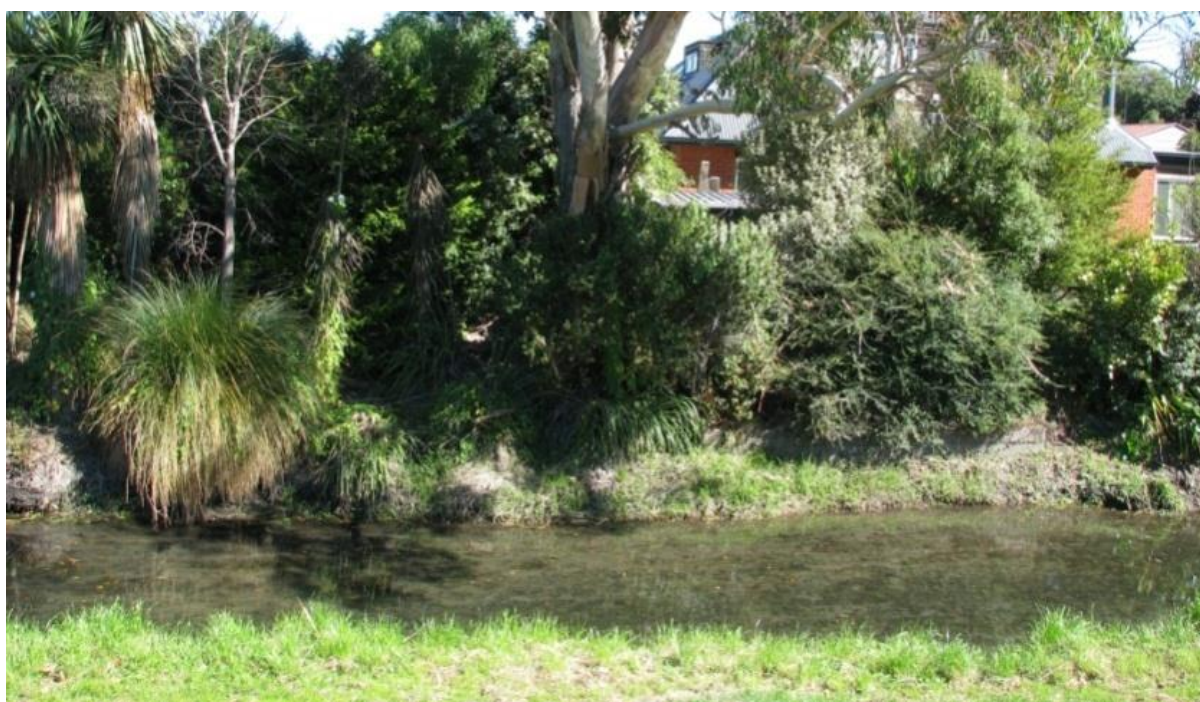
Riparian planting was observed at a number of sites although in many cases this is spatially limited due to constraints from urbanisation. An example is at the Pioneer Stadium site where native riparian restoration has been undertaken but is limited primarily to one side of the bank and confined by residential properties (Figure 28).

*Figure 28: Indigenous riparian species well established on one side of the waterway at the Pioneer Stadium site*

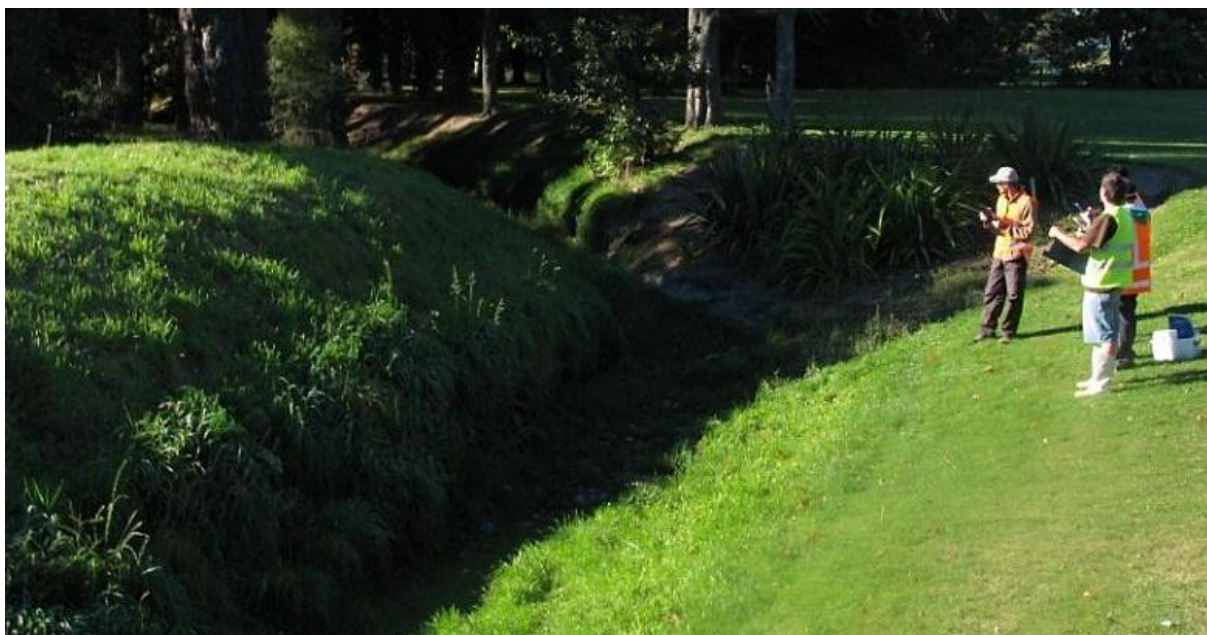
*Figure 29: The Wilmers Road / Warren Park site*

In the upper reaches of both the Avon and Heathcote rivers catchments of particular note was a loss of visible springs and water flow. The head of the Avon / Ōtākaro river is now just a remnant dry overgrown channel at the Avonhead site, while the upper Heathcote / Ōpāwaho at Warren Park contained only stagnant water from storm water inputs (Figure 29).

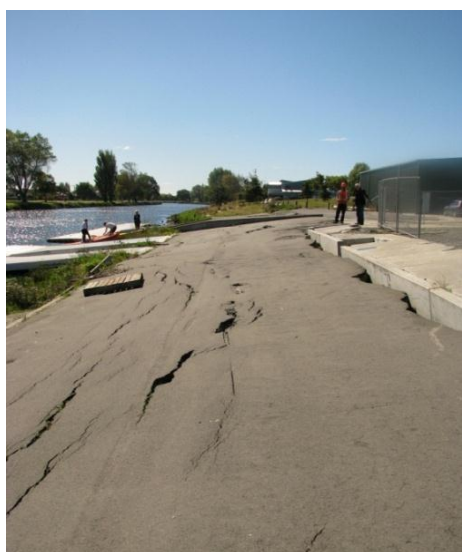
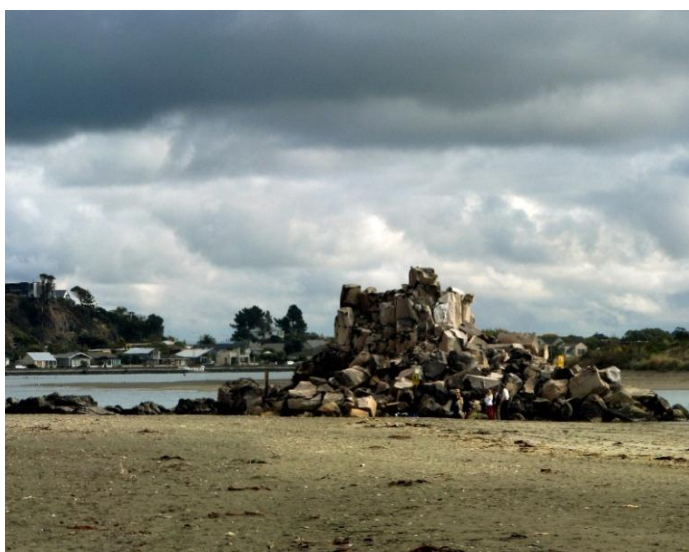
As identified in Pauling et al. (2007) the impacts of past and present modification and intensification of land use has had dramatic impacts on the cultural health of waterways in the Ihutai catchment, particularly in relation to drainage, stormwater and wastewater discharges. Waterway health issues have been further compounded by the series of earthquakes to strike Canterbury. Earthquakes effects have been particularly noticeable in the eastern part of the city, and have included damage to infrastructure and utilities in and around the waterways, increased pollution from a variety of sources, and direct damage to culturally important sites such as Rapanui (Shag Rock) (Figure 30).

*Figure 30: Examples of earthquake damage at Kerrs Reach (left) and Rapanui (right)*
