State of the Takiwā 2012

Ruataniwha / Cam River

Cultural Health Assessment of the Ruataniwha / Cam River and its catchment

Hakihea / December 2012

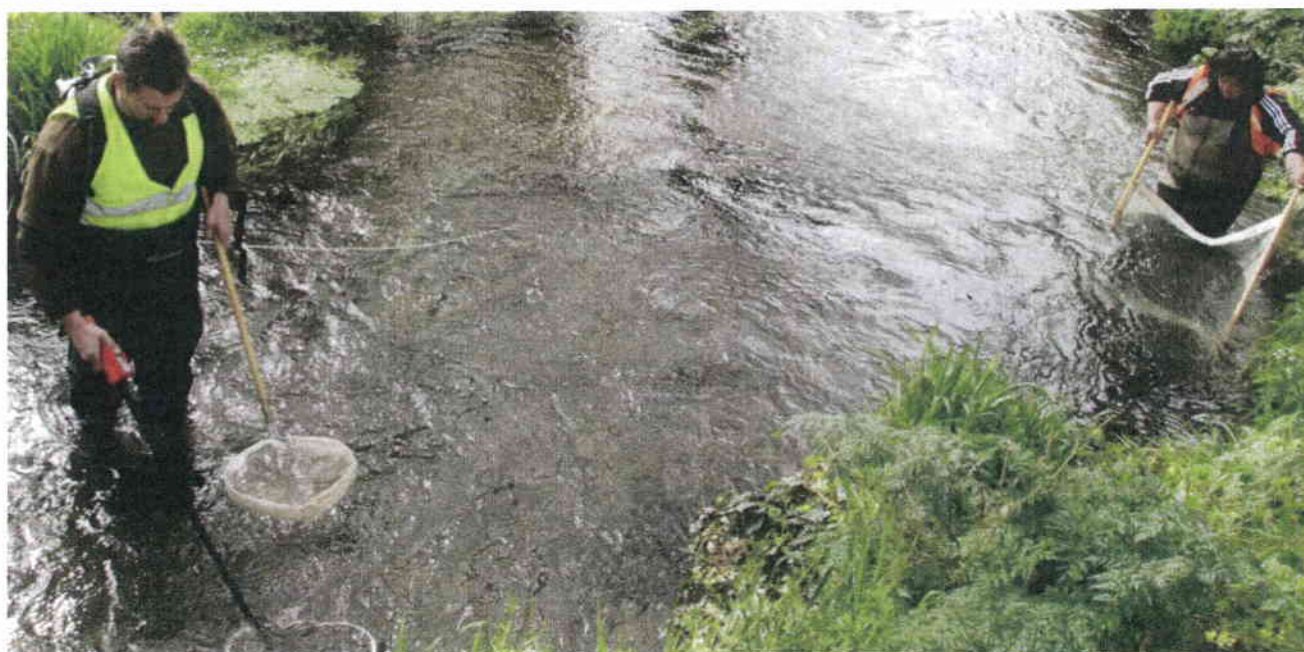
Figure 3: Electric fishing at O-Tumatapura.

This study utilised the Kainga EFM 300 packset in-conjunction with a hand held scoop net and larger mesh net. The EFM300 consists of a battery-powered backpack generator unit, a fibreglass wand with cathode, and an earthing wire. Both machine and net operators wear full length neoprene waders and rubber safety gloves, with cotton inners during surveying (Figure 3). Surveying was conducted over varying distances, but typically between 10 and 30 metres with a single pass over each bank. The total time taken to complete electric fishing surveys was typically 10 to 20 minutes.

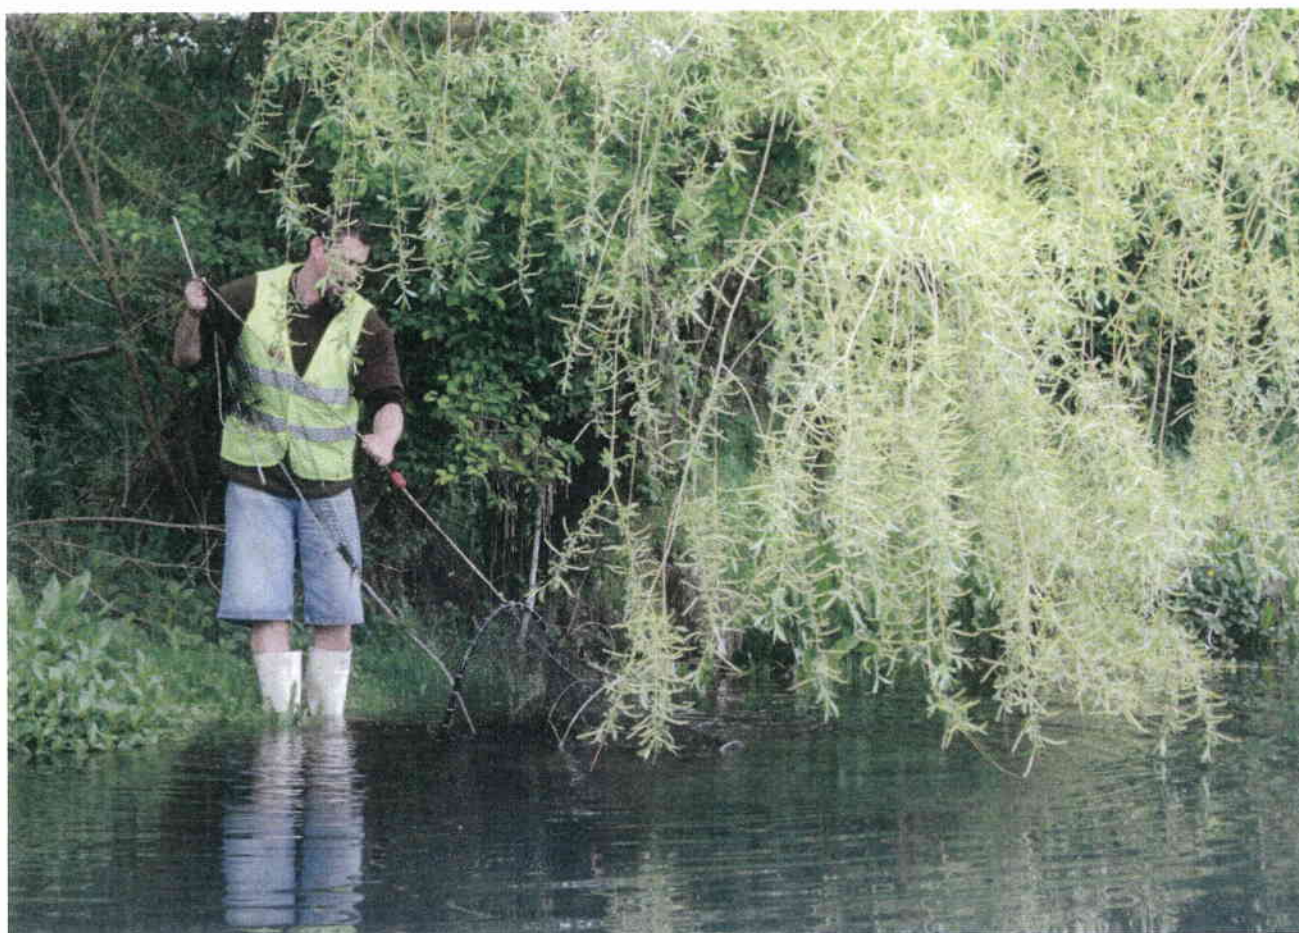
Figure 4: Setting a hīnaki at the Ruataniwha / Revells Road site.

A single hīnaki baited with fish frames and scraps was set at each of nine locations over two days on the 26th and 30th September. These sites were selected on the basis of being not amenable to electric fishing, and where ease of access and safety of team members and equipment was acceptable for the setting of hīnaki. In each case the hīnaki remained set overnight and was collected on the following morning and their contents assessed (Figure 4).

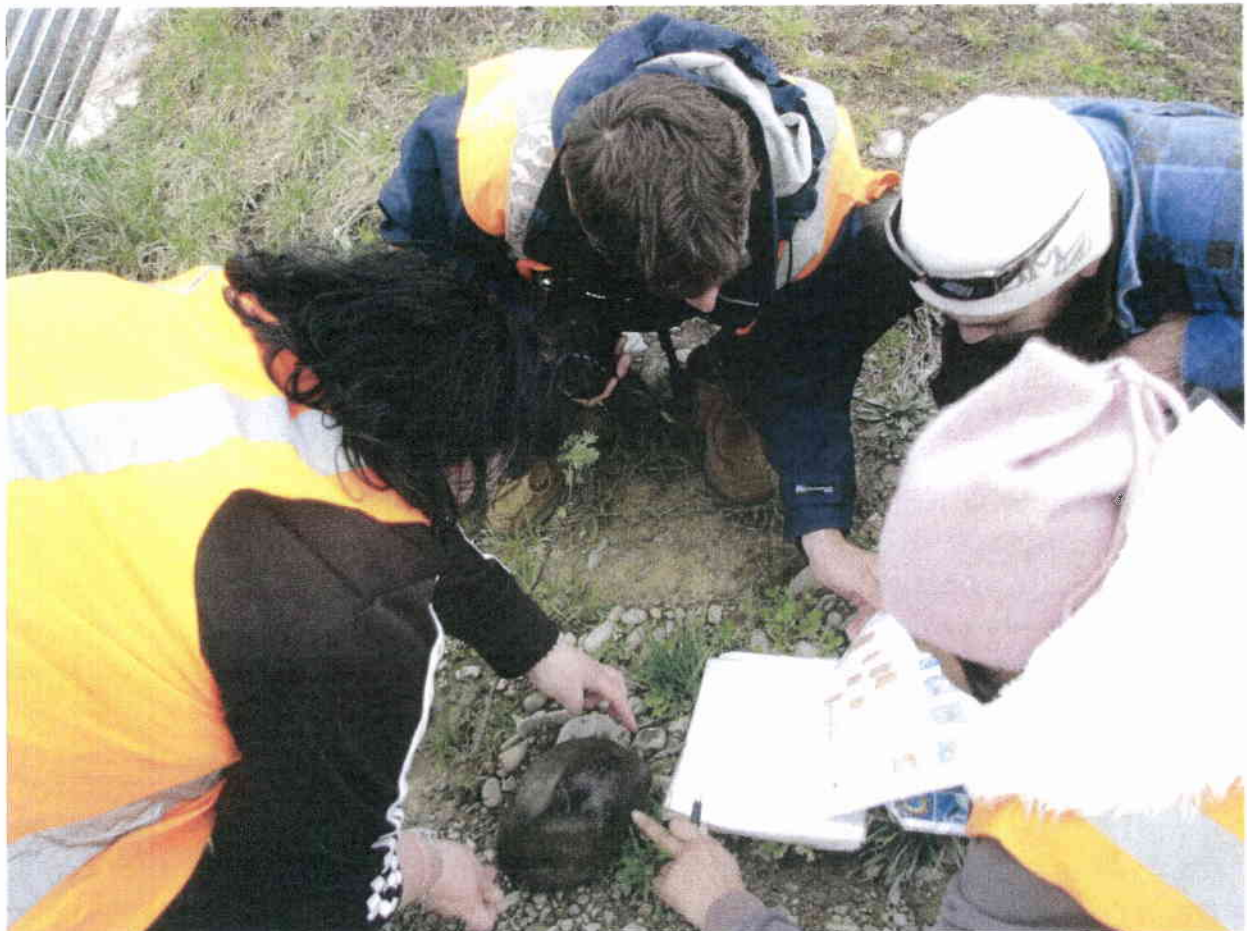
Figure 6: The roopu engaged in a SHMAK assessment at the Flaxton water treatment facility site.

The methodology used for this State of the Takiwā programme involved assessment of the SHMAK Stream Bed Life parameters only, which involve assessments of the invertebrate and periphyton communities present (see Figure 6). The invertebrate assessment was based on five randomly selected stones in the stream bed which were scored for presence or absence of 17 invertebrate taxa as per the standard SHMAK method (Appendix 3). The same five stones were also assessed for periphyton presence/absence using the standard SHMAK method (Biggs et al., 2001). Scores from all SHMAK assessments conducted contributed to the SHMAK Stream Habitat Health index score calculated in Takiwā 2.0.

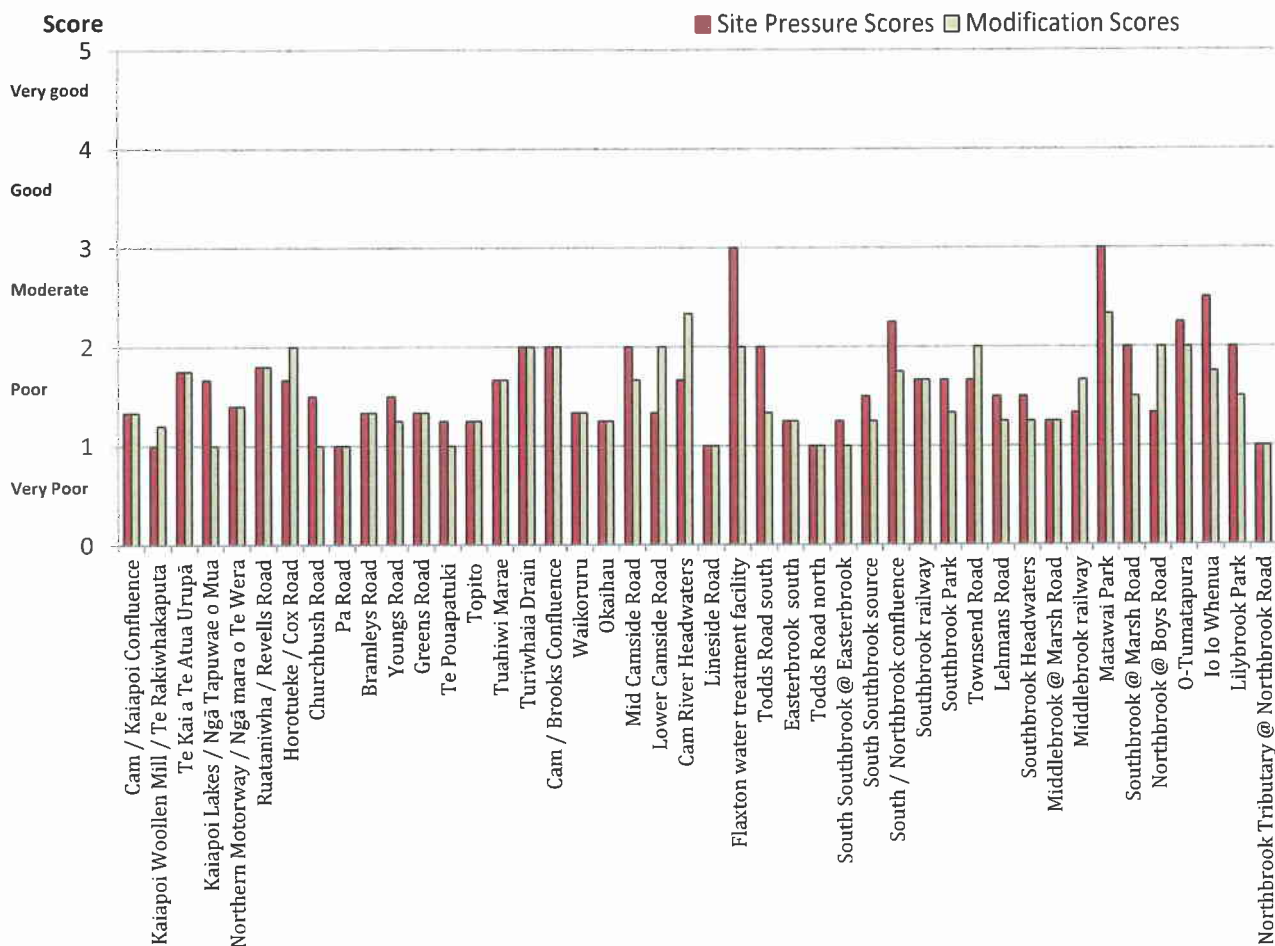
Takiwā assessment scores relating to the amount of pressure and the degree of modification at each sites show that most sites in the catchment are in poor condition in respect to these criteria, with just a small number of sites in moderate condition. The majority of sites were considered to be highly modified (relative to traditional condition) and also currently experiencing a high level of pressure with respect to the maintenance of cultural values (Figure 11).

Figure 11: Scores for levels of modification and pressure on monitoring sites.

Sites which were scored as having high levels of pressure and modification were typically sites where exotic species were abundant or where agriculture dominated, and where there was a lack of native riparian species within the waterways and their margins.

These sites at which moderate scores were achieved typically have undergone restoration of native plant species or where there is a reasonable buffer between the waterways and unfavourable adjacent land uses.

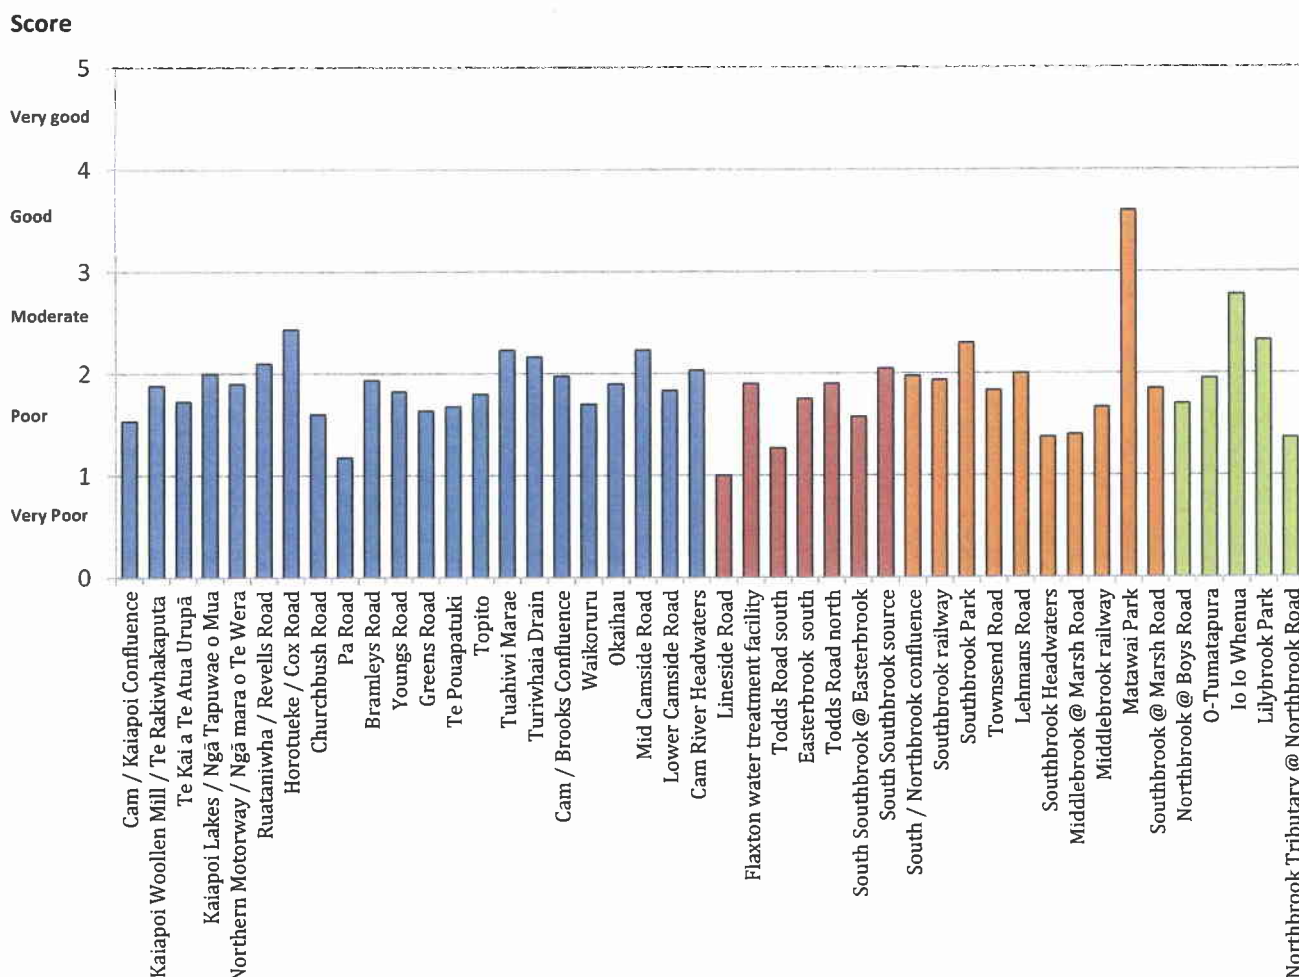
Results from the Takiwā 2.0 Overall Health Index calculation returned scores indicating that cultural health of the majority of sites in the catchment was poor. The average score across the catchment was 1.9 out of a possible score of five. On the one to five scale, no sites were assessed as being in 'very good' condition, only a single site in 'good' condition, nine sites (20.5%) in 'moderate' condition, and 34 sites (77.3%) in either 'poor' or 'very poor' condition (Figure 12).

Figure 12: Takiwā 2.0 Overall Health Index scores.

Blue = Cam River/Cam Drains, Red = South-Southbrook, Orange = South & Middle brooks, Green = Northbrook

The site at Matawai Park scored the highest (3.6/5), with Io Io Whenua scoring the next highest with 2.8, followed by Horotueke / Cox Road (2.4/5) and Lilybrook Park (2.3/5). In contrast, many sites across the catchment were rated poorly. The lowest of which was Lineside Road with the lowest possible score of 1.0 / 5, with Pa Road scoring 1.2 / 5 and Todds Road south scoring 1.3 / 5.

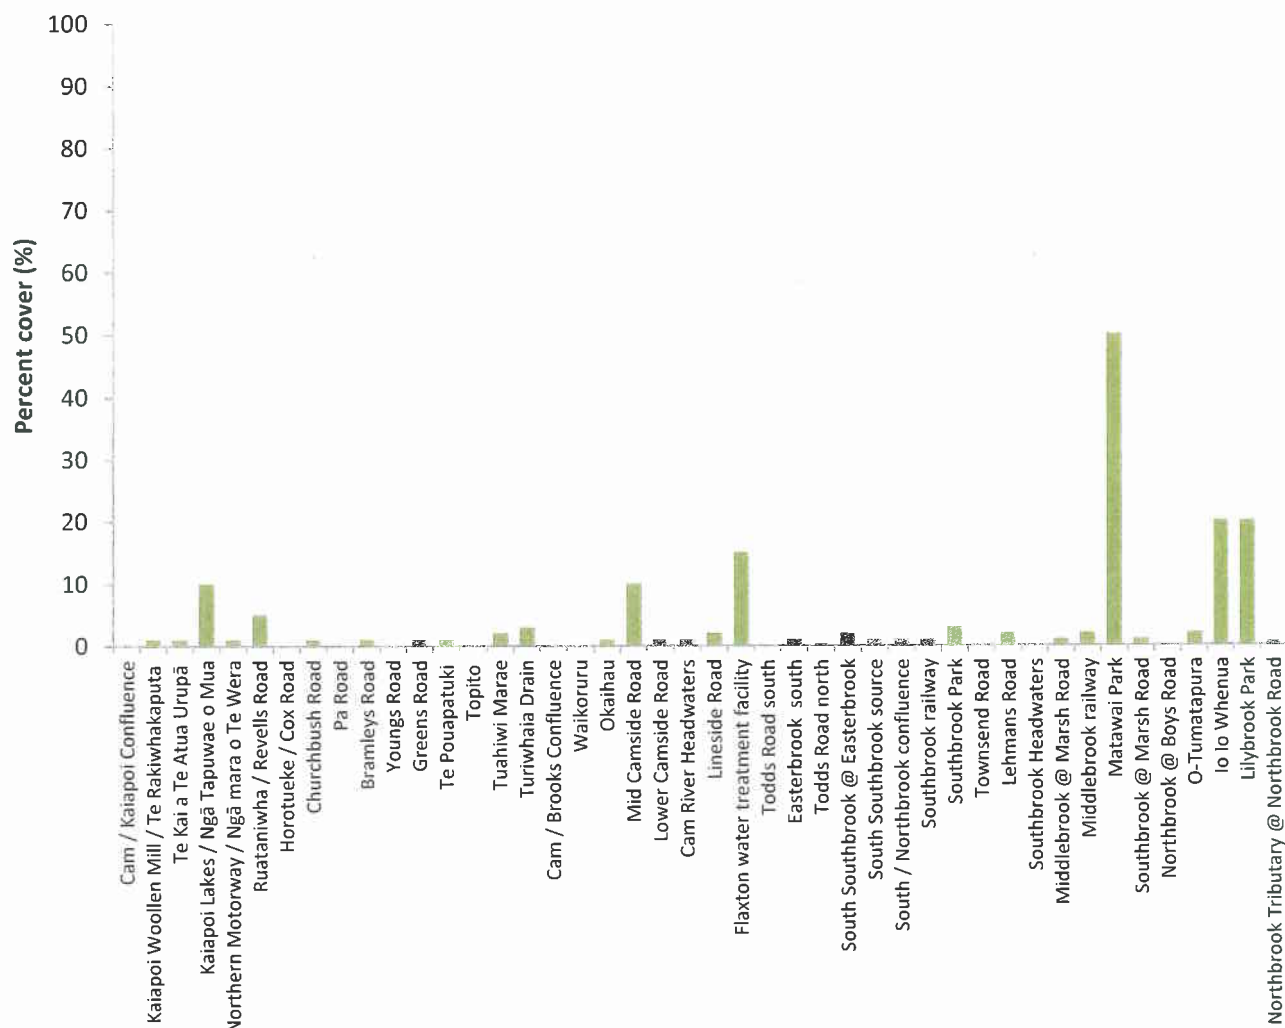
Although the vegetation richness results indicate the presence of some indigenous plant species of importance to Ngāi Tahu, the overall density of indigenous vegetation was extremely low at nearly all monitoring sites in the catchment (Figure 14). With the exception of a few sites, the majority of the catchment is dominated by exotic grasses and weeds.

Figure 14: Percent cover of native vegetation recorded at monitoring sites.

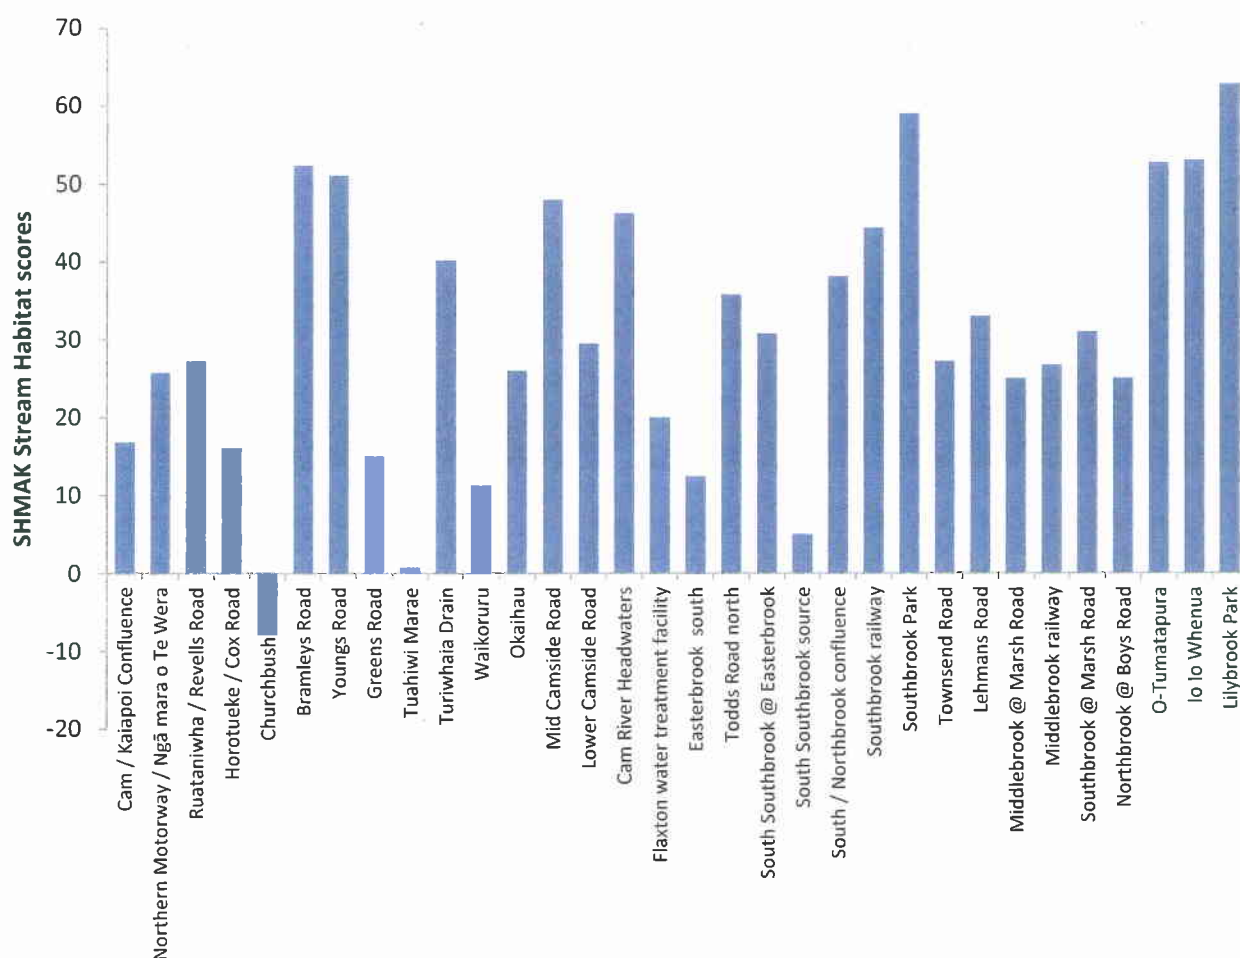
Results from the SHMAK Stream Habitat Assessments were variable across the catchment with a slight trend towards improved habitat conditions towards the headwaters/source of the catchment, which typically had better water clarity due to the proximity to freshwater springs (Figure 21). The highest scores were found at Lilybrook Park (43) and Southbrook Park (32) whilst the lowest scoring site was Churchbush Road (-8).

Figure 21: SHMAK Stream Habitat scores.

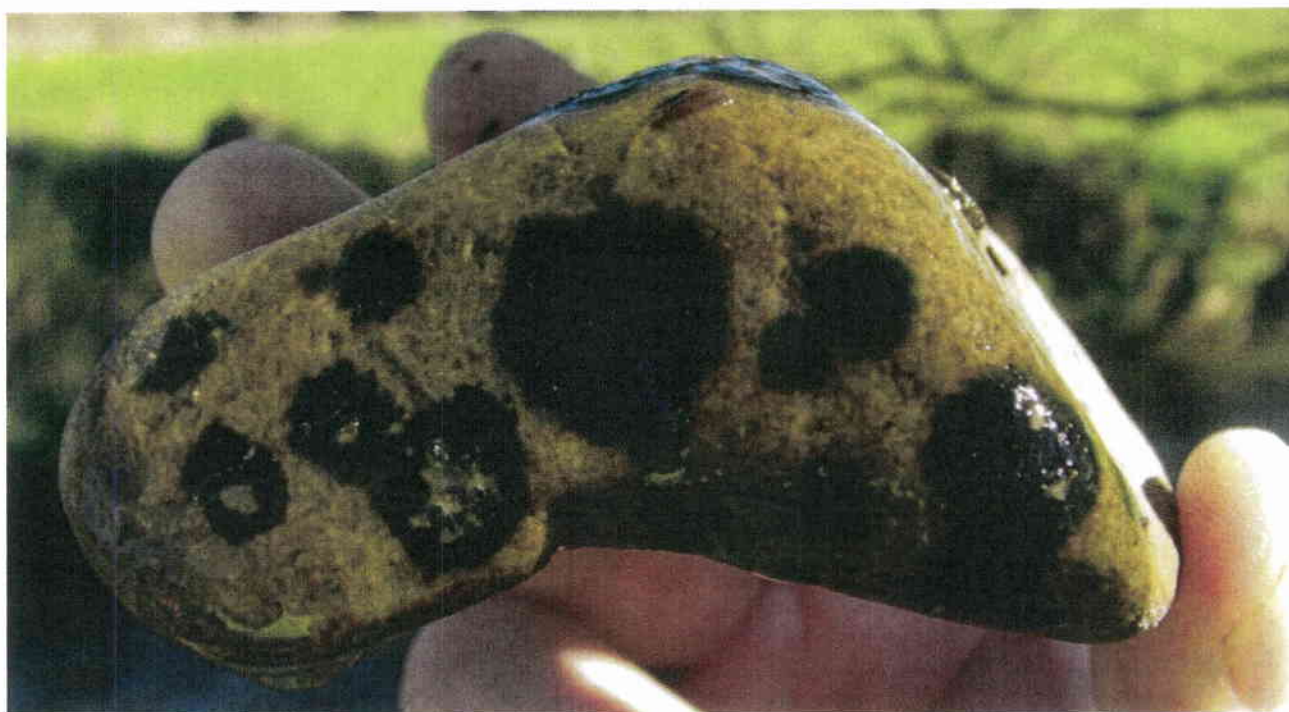
Figure 22: Periphyton and invertebrates on a rock sample at the South / Northbrook confluence.

The scores obtained in this assessment are based on the presence of various invertebrates and periphyton located on rock samples (Figure 22) which are scored based on NIWA's invertebrate and periphyton assessment kit. Both the invertebrate and periphyton scores are based on a scale from 1 – 10, with 10 being the highest score possible.

Scores from the Invertebrate assessment ranged from 2.4 to 6.5 with the average score from all sites measured being 4.8. The best score was recorded at Townsend Road and the lowest score at Io Io Whenua which likely reflected the lack of flowing water at that site.

Scores from the periphyton assessment ranged between 8 and 10 indicating relatively healthy in-stream conditions for periphyton (Figure 23).

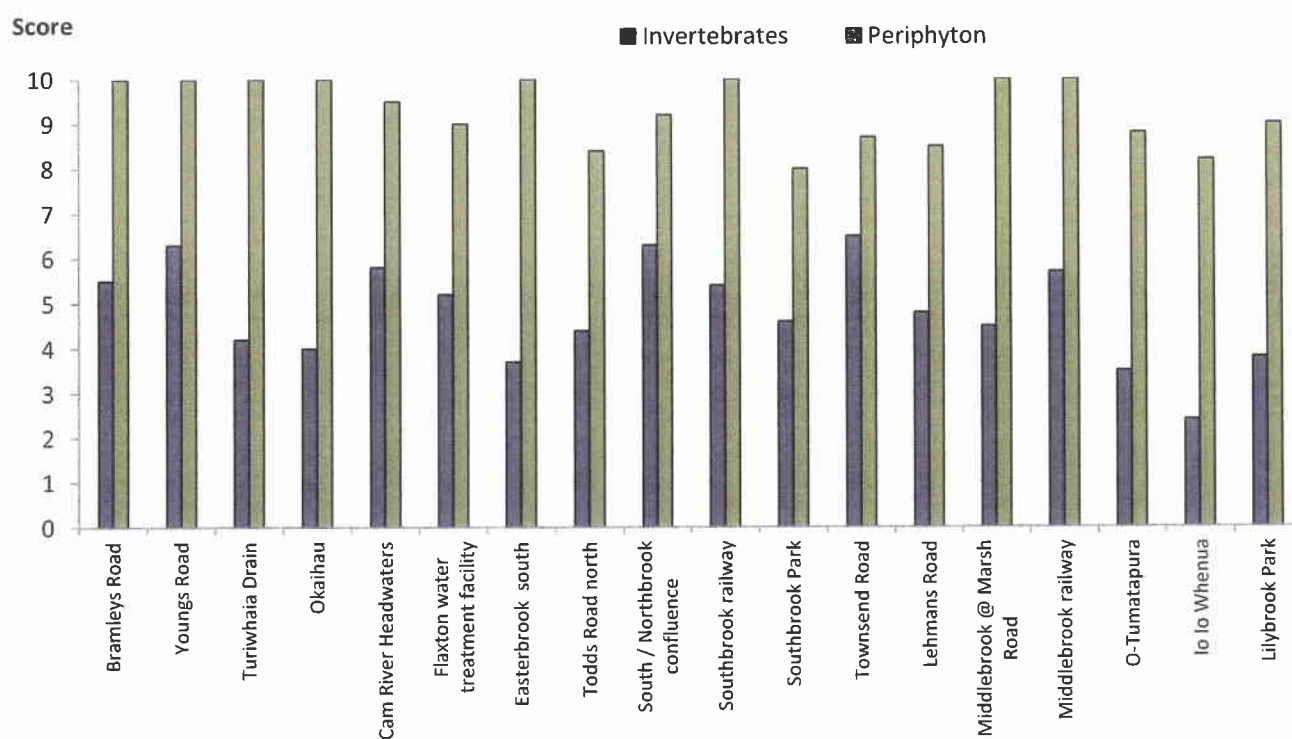
Figure 23: SHMAK Invertebrate and Periphyton scores.

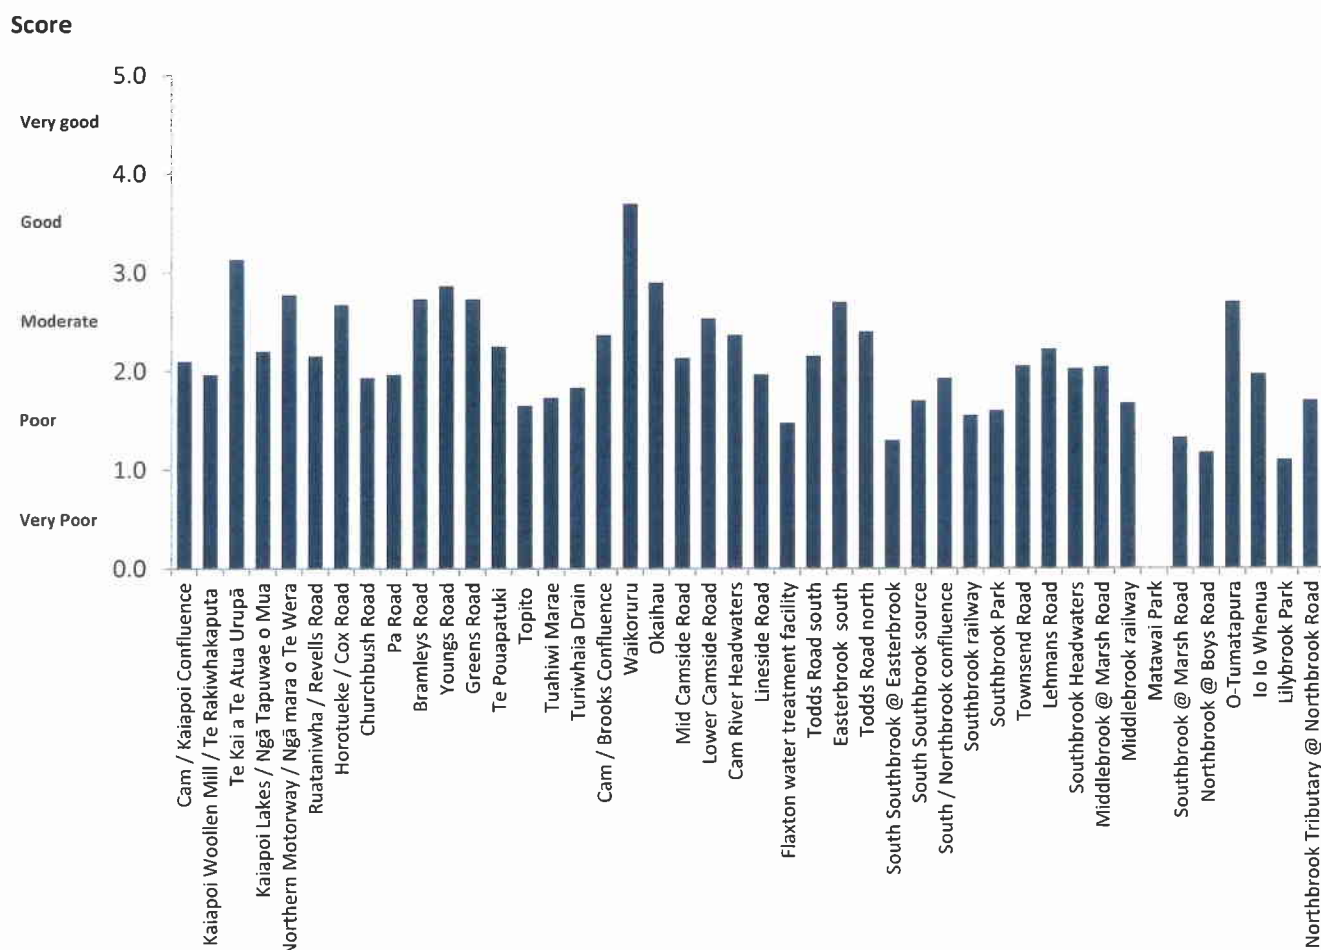
Results from the CHI Stream Health Assessment indicate that stream health is degraded across the catchment with average score across the 42 sites assessed being 2.1 on the one to five scale used (Figure 24). Of those sites, 50% scored two or less and 40 sites returned scores of three or less. The two best scores were recorded at the Head of the Cam and Matawai Park sites, both of which are located near the source of the respective streams / tributaries and are in close proximity to springs.

Figure 24: CHI Cultural Stream Health Assessment scores.

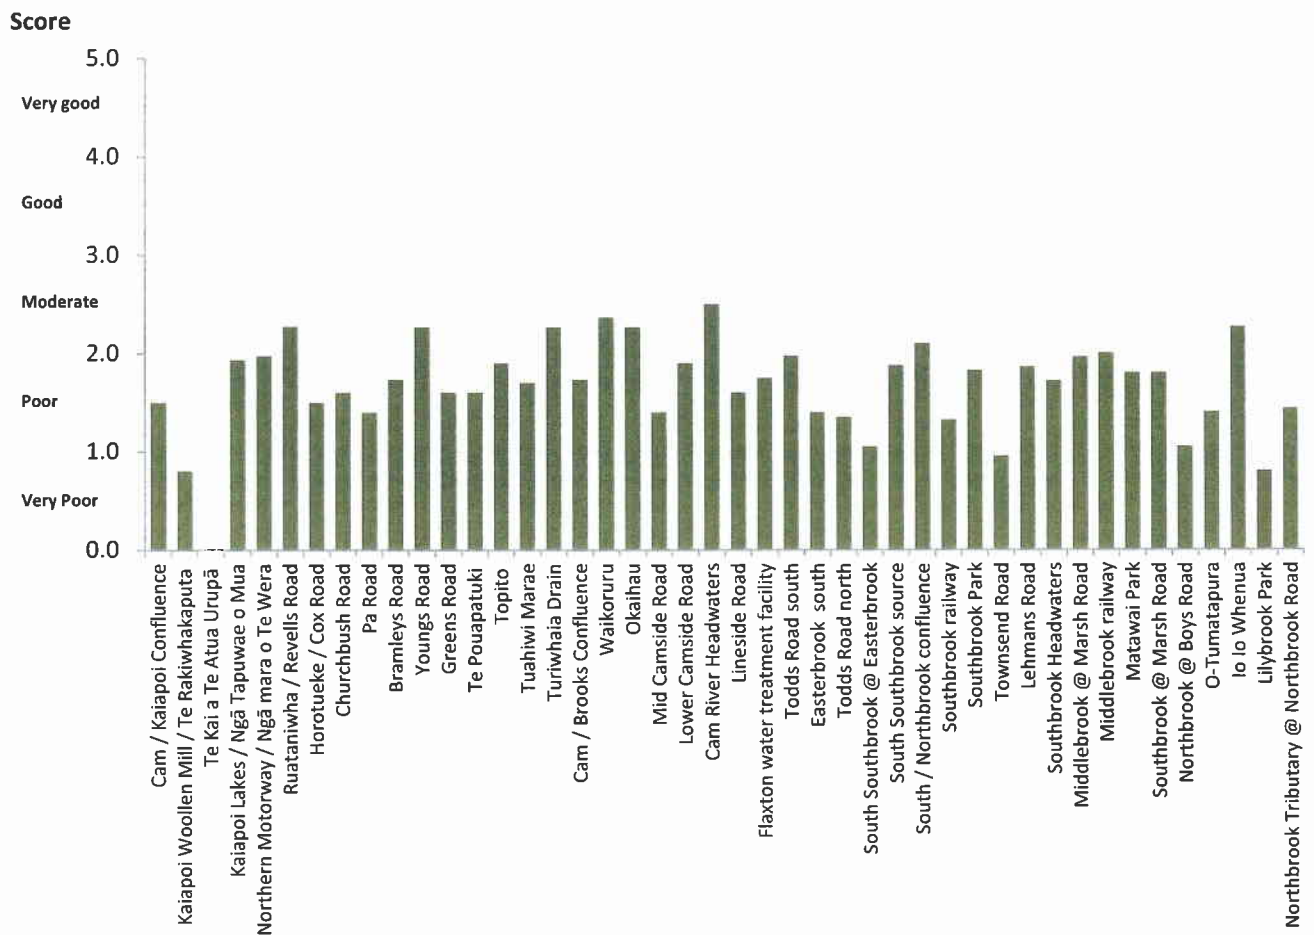
A range of factors were considered by the roopu in the CHI Mahinga Kai Index assessment, including the presence and abundance of mahinga kai resources, condition of those resources, and health of the overall site including exposure to pollution sources and other sources of degradation. As a wāhi tapu, the site close to Te Kai a Te Atua Urupā was not included in these assessments.

However, the roopu noted that there was potential for future mahinga kai activities at almost all sites if the abundance of resources increased and improvements in other aspects of cultural health were made.

Figure 27: CHI Mahinga Kai Index scores.

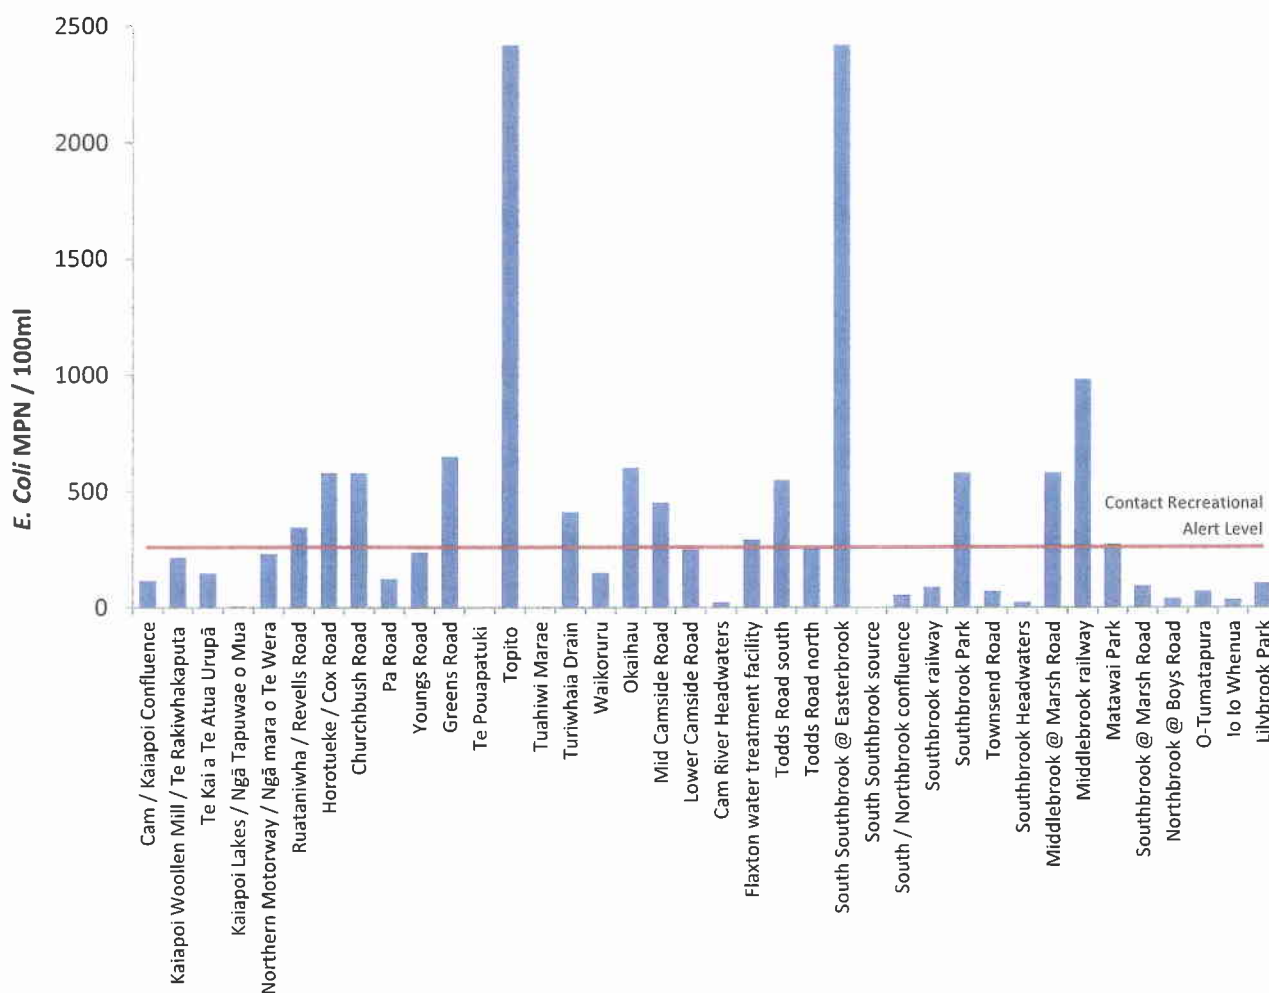
Figure 28: *E. coli* levels at monitoring sites.

Fifteen sites (39%) exceeded the Recreational Alert level of 260 *E. coli* /100ml at the time of sampling. There were also several sites where *E. coli* levels were very low. The lowest level recorded was three (3) *E. coli* / 100ml at the South Southbrook source. Other sites of note included Te Pouapatuki (5 *E. coli* / 100ml), a roadside drain, Tuahiwi Marae (4 *E. coli* / 100ml), a small drain behind the marae, Kaiapoi Lakes / Nga Tapuwae o Mua (7 *E. coli* / 100ml) and the Cam River Headwaters site (22 *E. coli* / 100ml). Many of these sites are characterised by springfed sources nearby.

Sites along the mainstem of the Ruataniwha / Cam River were typically found to have higher levels of *E. coli* pollution compared to Northbrook and Southbrook sites at the time of sampling, and some sites contained extremely high *E. coli* levels.

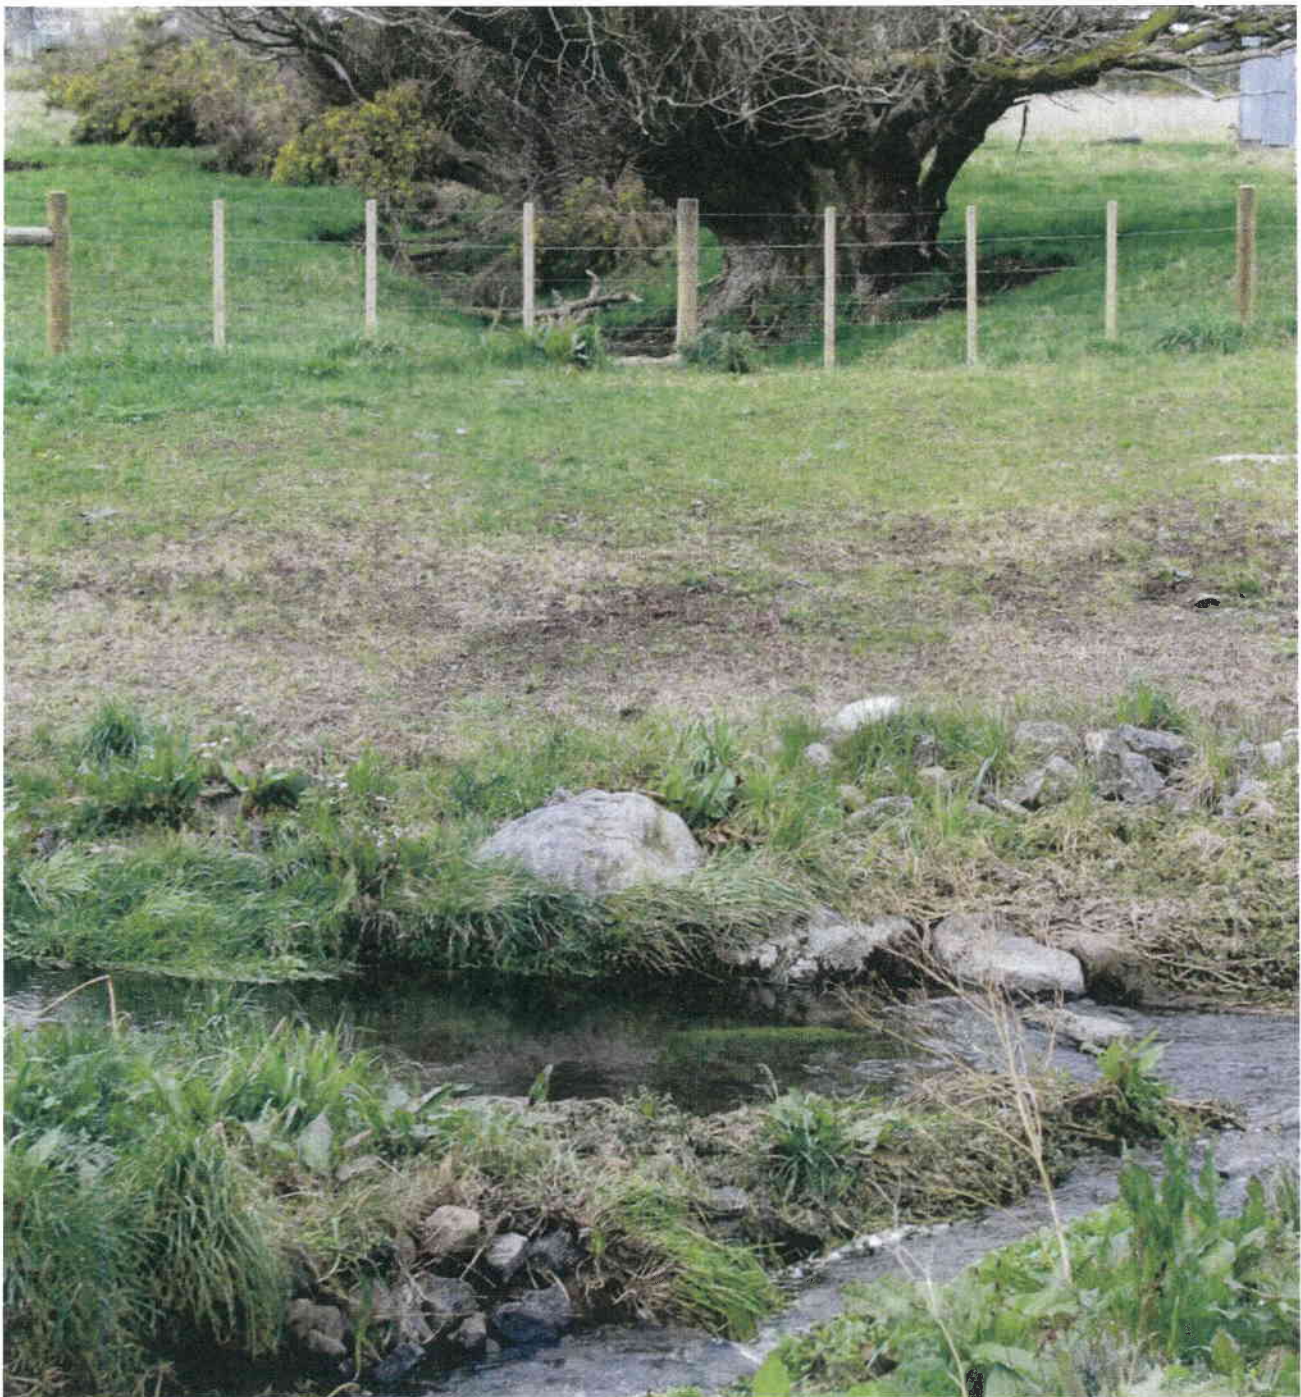
Figure 31: An example of a diverted waterway at the Todds Road south site where the stream has been diverted away from its natural alignment (adjacent to the line of trees in background). This stream also no longer feeds into the Ruataniwha / Cam River having been diverted into the Cust Main Drain catchment.

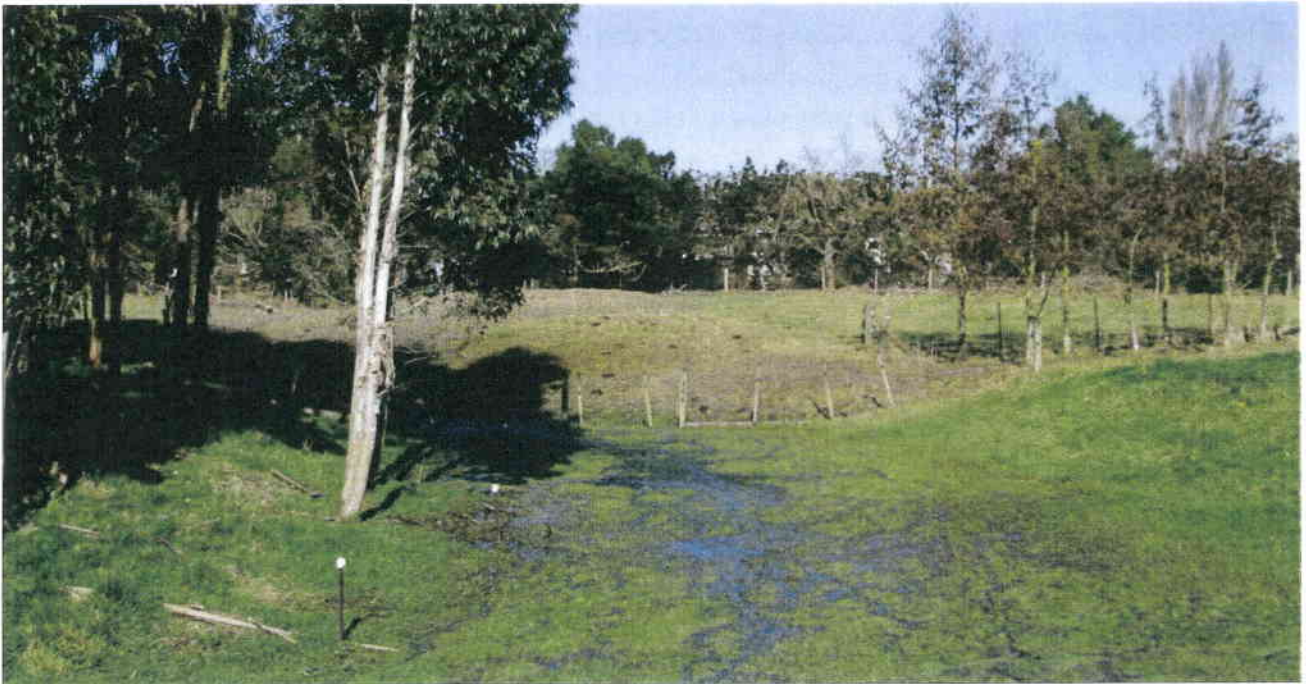
Figure 32: An example of a site which has undergone recent modification to block a natural waterway and convert land for agricultural use at Pa Road.

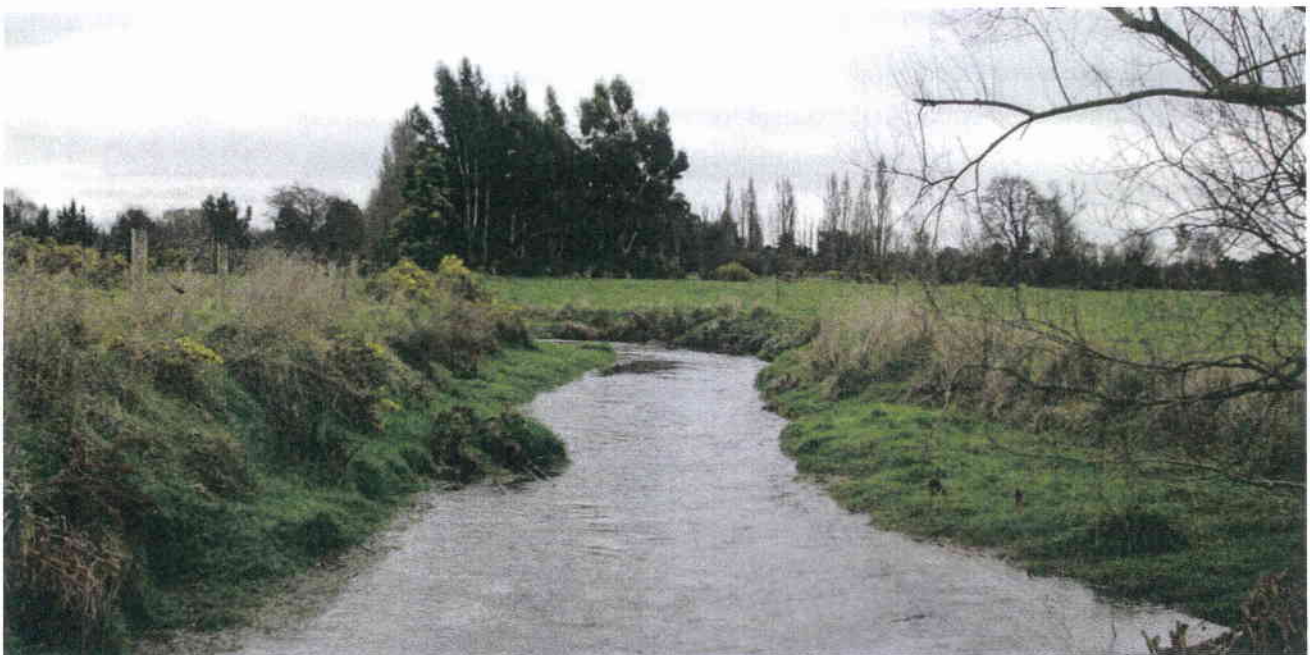
Figure 33: The South Southbrook source site which is typical of many sites across the catchment. The waterway is surrounded by farmland and dominated by exotic species with little native vegetation present. Habitat conditions for many indigenous and mahinga kai species are poor.

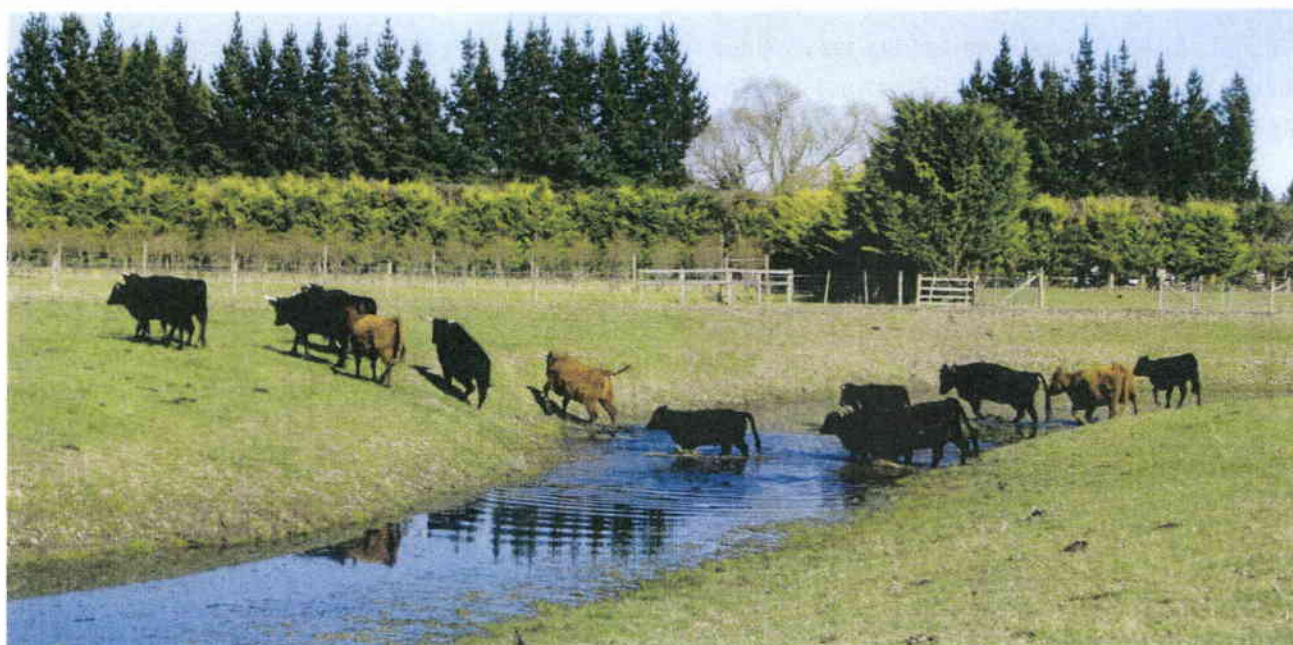
Figure 34: The condition of many monitoring sites for mahinga kai was assessed as being low. A lack of mahinga kai resources, poor condition of resources, and presence of pollution sources were contributing factors observed at many sites. Here cattle are seen freely entering a waterway at the Pa Road site.

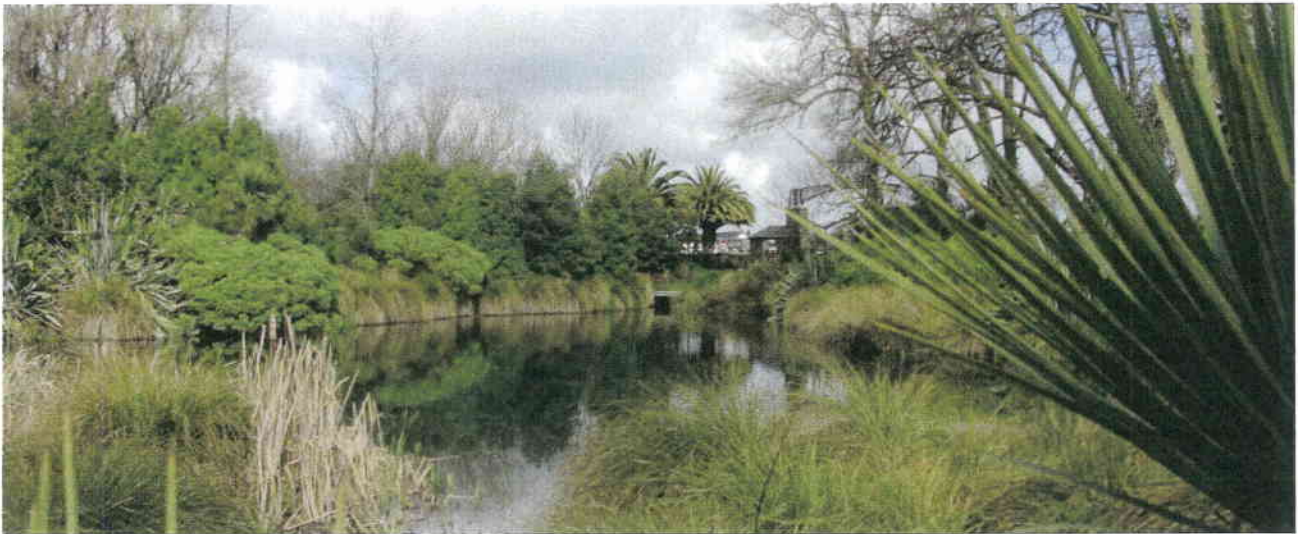
Figure 35: An example of ecological restoration at the Io Io Whenua site.

The State of the Takiwā monitoring sites included some examples of well-established restoration initiatives, notably at Io Io Whenua and Matawai Park. These sites scored well in a number of assessment modules illustrating the positive impact of restored riparian areas for cultural health (Figures 35 and 36).

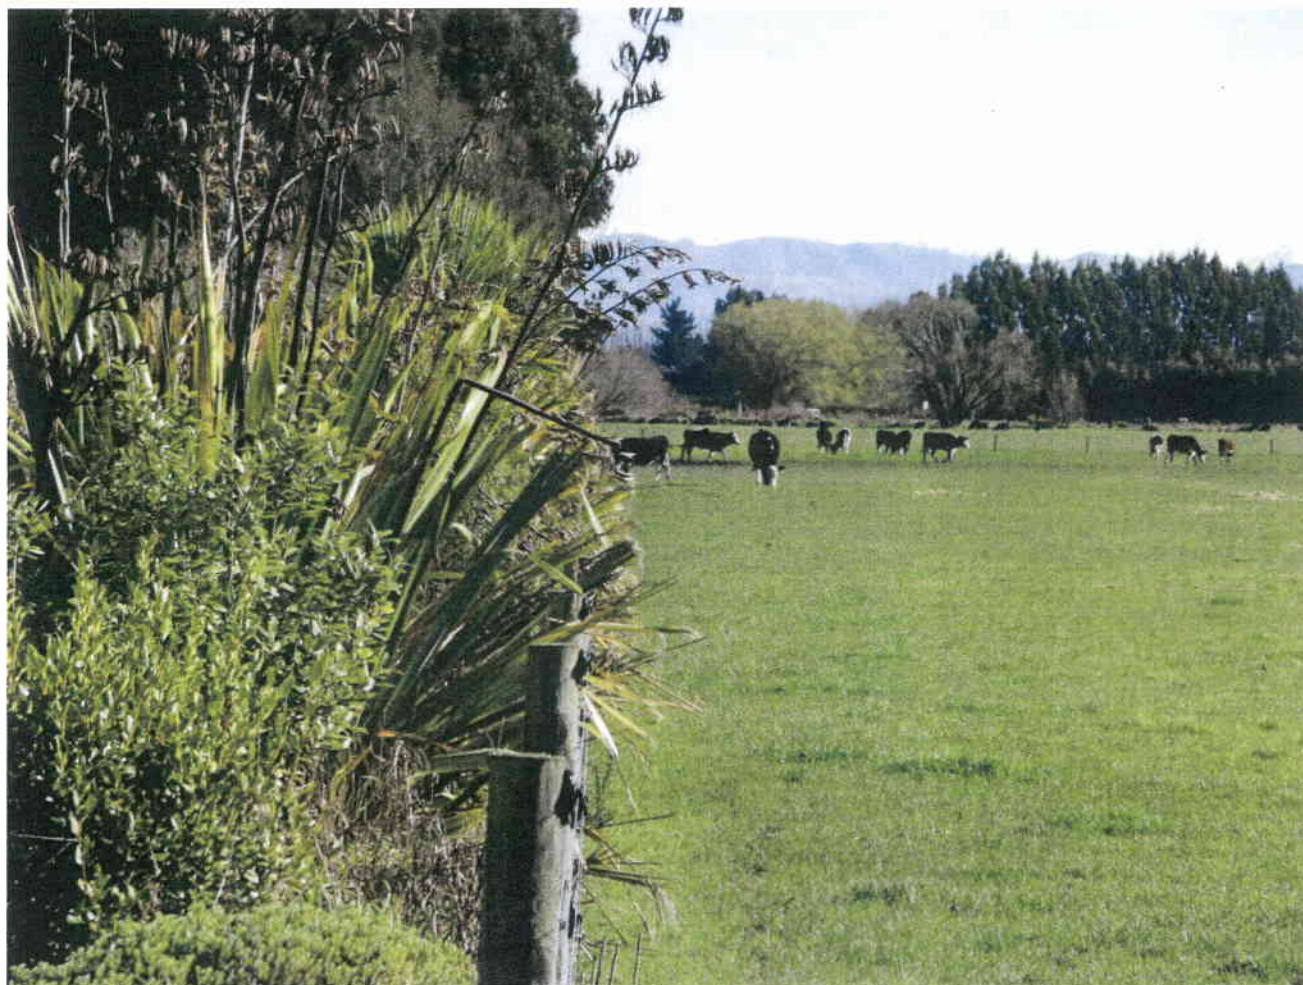
Although as discussed above there were few examples of stream and drain sites with restored or remnant indigenous vegetation in the riparian zone, an exception was the Turiwhaia Drain site where an appropriate area had been fenced off and well established indigenous plant cover was present (Figure 33).

Figure 33: The Turiwhaia Drain site; an example where riparian planting has been undertaken and the waterway fenced off to provide a buffer zone to the surrounding land uses.
