State of the Takiwā 2012

Ruataniwha / Cam River

Cultural Health Assessment of the Ruataniwha / Cam River and its catchment

Hakihea / December 2012

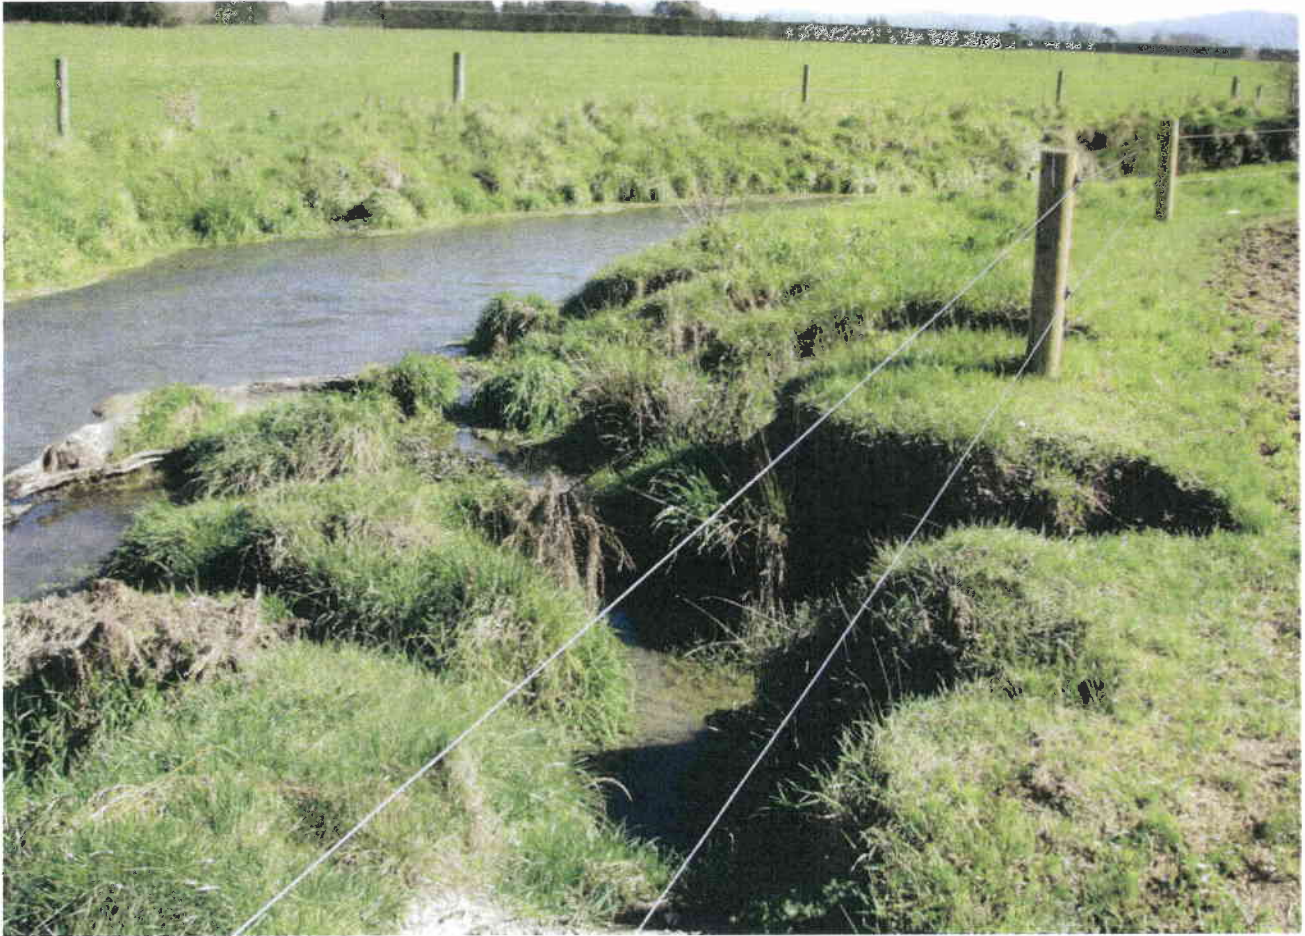
Figure 34: Ineffective riparian management at the South / Northbrook confluence site.

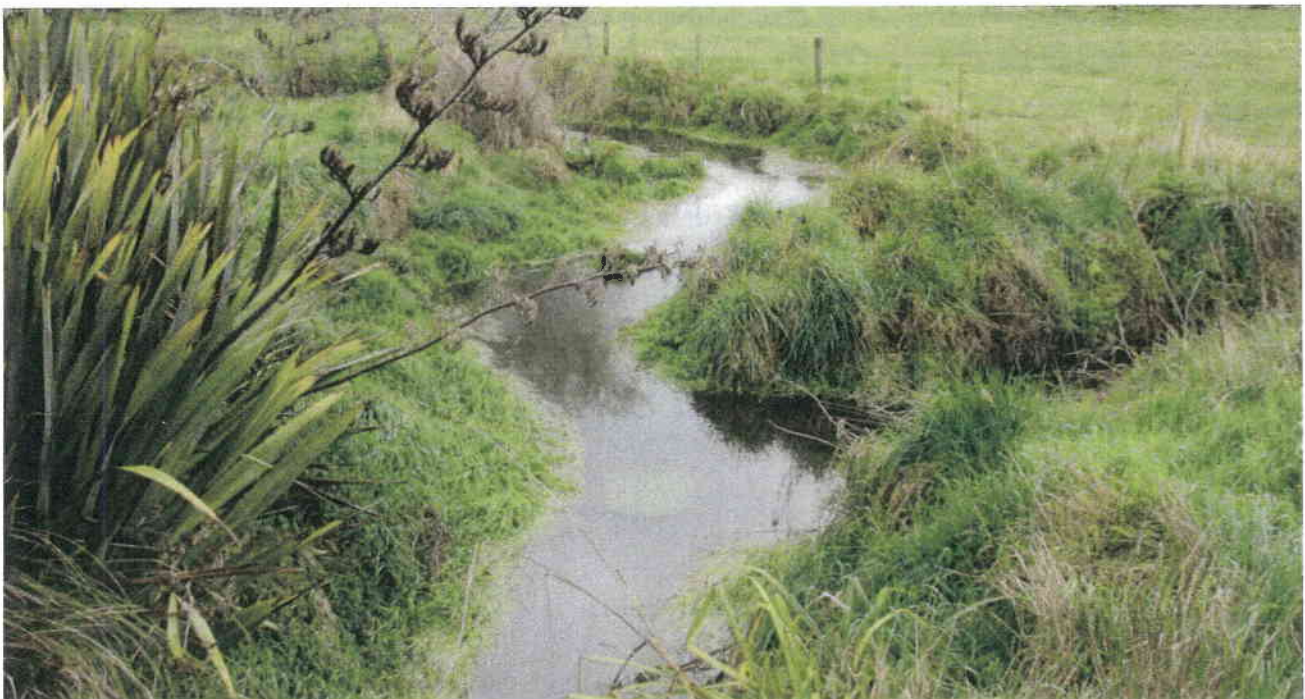
However at some sites such as the Southbrook Railway site, the fencing arrangement was designed to allow a more sinuous stream form to persist (Figure 35).

Figure 35: The Southbrook Railway site.

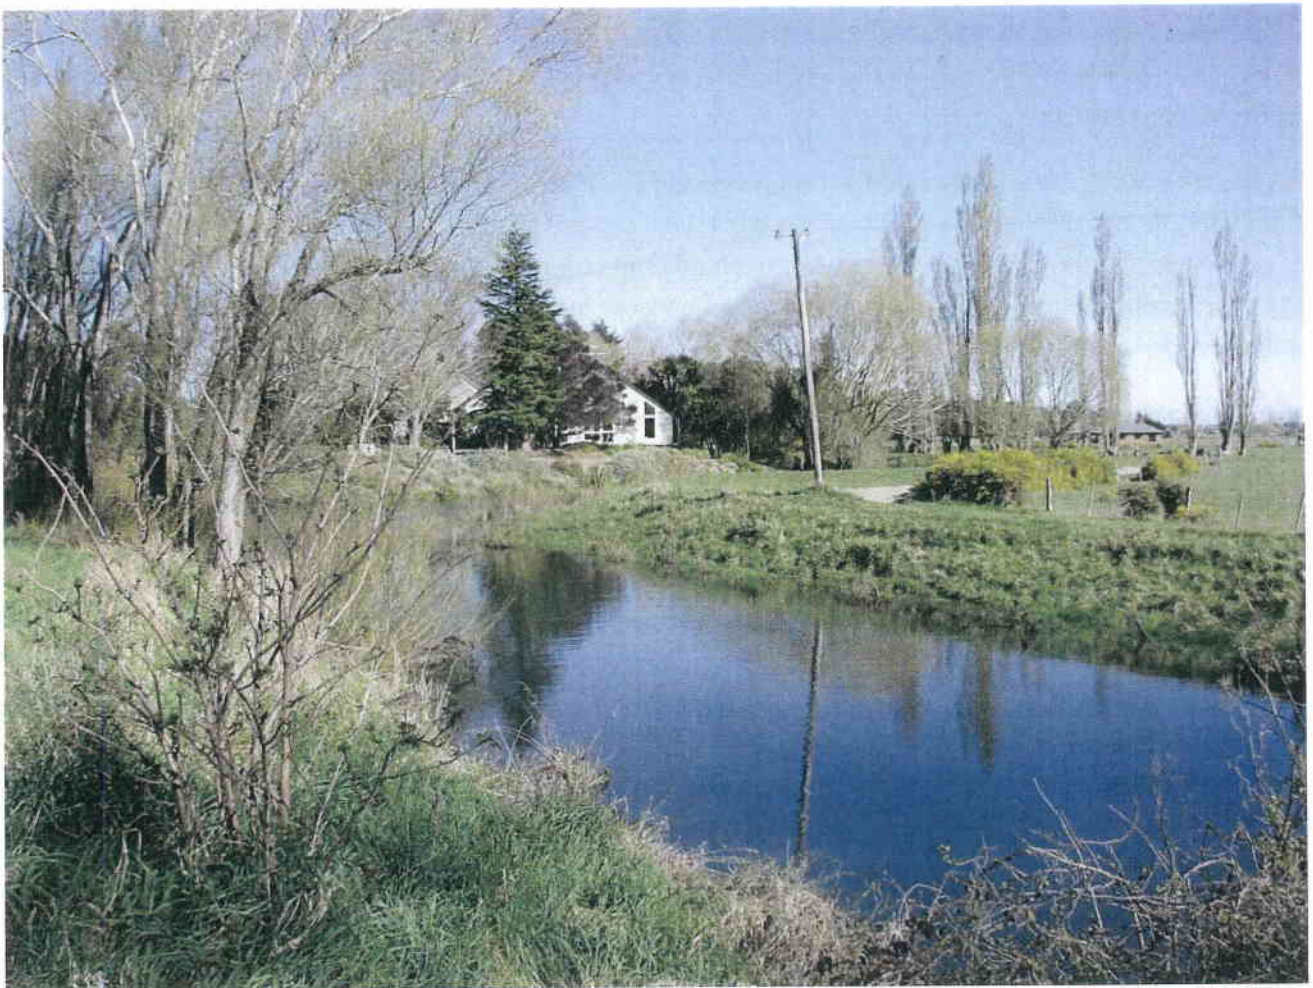
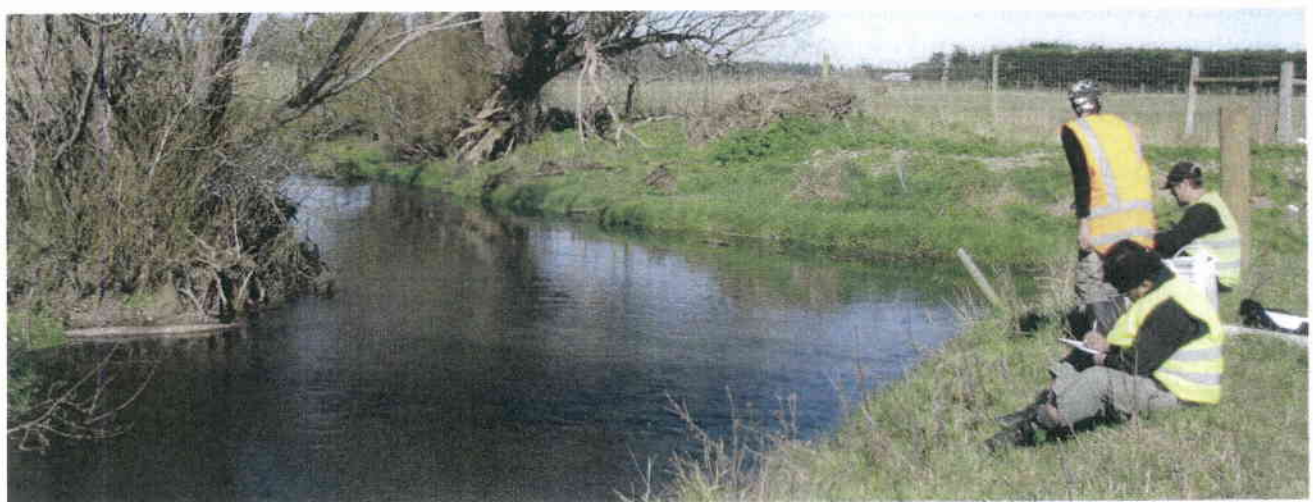
Figure 36: A typical view of the lower Ruataniwha / Cam River, showing highly modified riparian and surrounding areas and a lack of the indigenous vegetation which was formerly present (above), and the roopu at work at the Cam / Brooks Confluence site (below).
